Home Inspection Report

123 Sample St.

Chicago, IL

Inspected on Fri, Mar 8 2019 at 10:00 AM

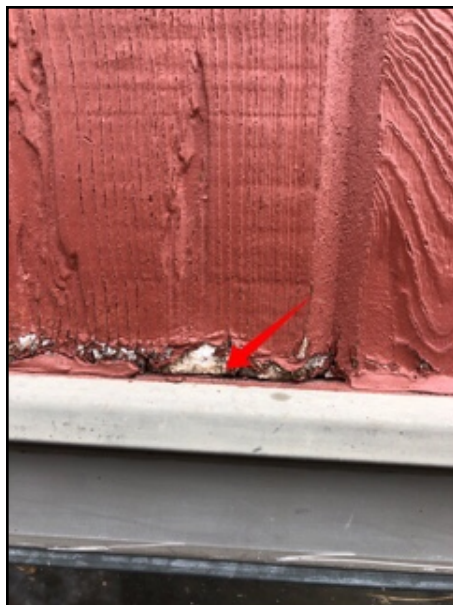
Figure 3-1

Paint peeling on sections of the siding. Recommend re-painting the affected areas to prevent possible rot of the siding.

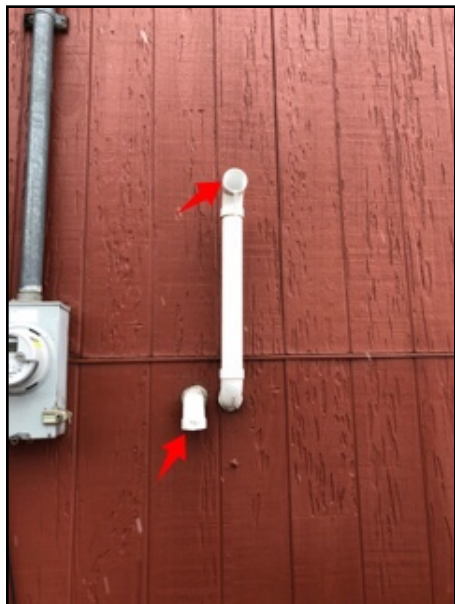
Figure 4-1

- ⚠ Comment 4:
Exterior PVC exhaust and intake vents are recommended to be covered with screens to reduce the opportunity of possible insect and bird infiltration.

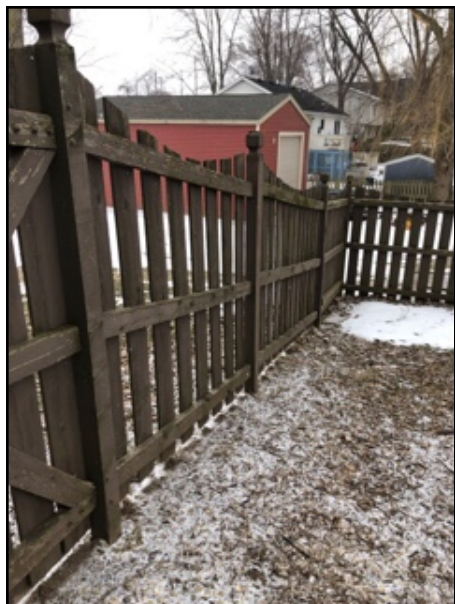
Figure 5-1

-
- ⚠ Comment 5:
Fence is recommended to be power washed and re-sealed.

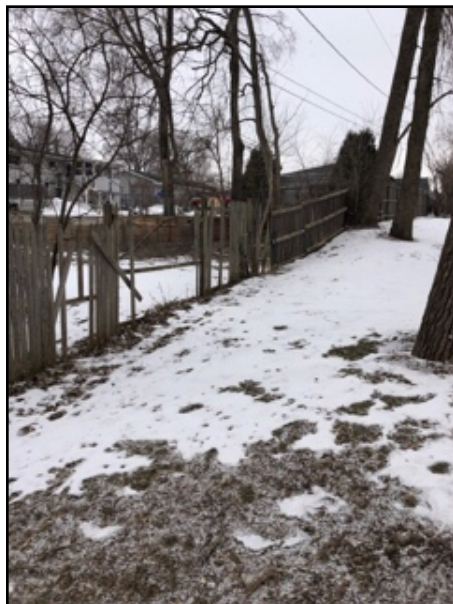
Figure 6-1

Sections of the fence are loose damaged and missing. Recommend replacing the affected sections of fence.

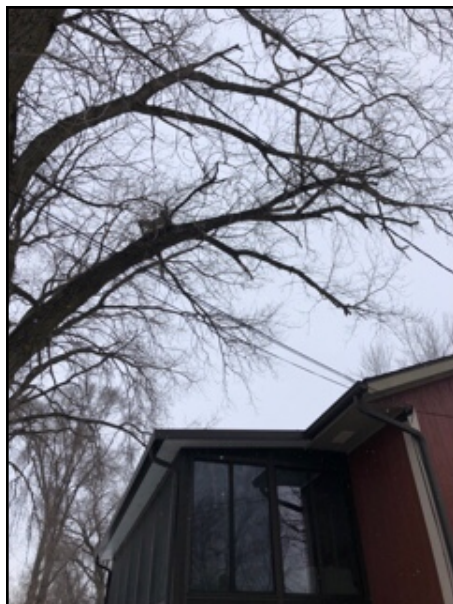
Figure 7-1

Recommend removing all tree branches overhanging the roof of the home.

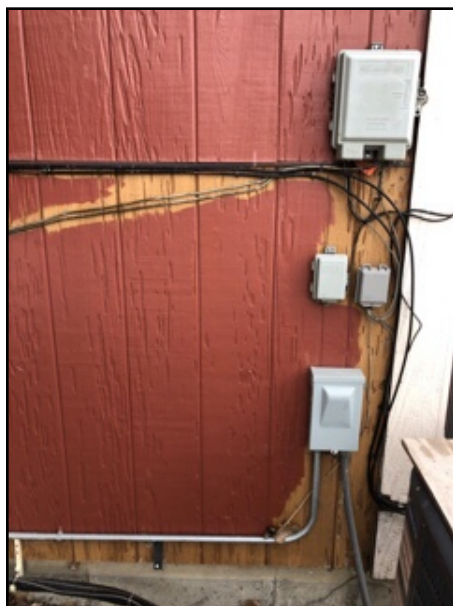
Figure 8-1

Recommend painting all unpainted sections of the siding to prevent possible rot.

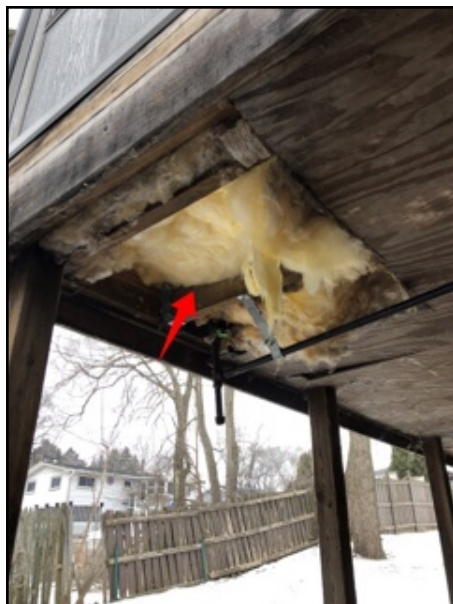
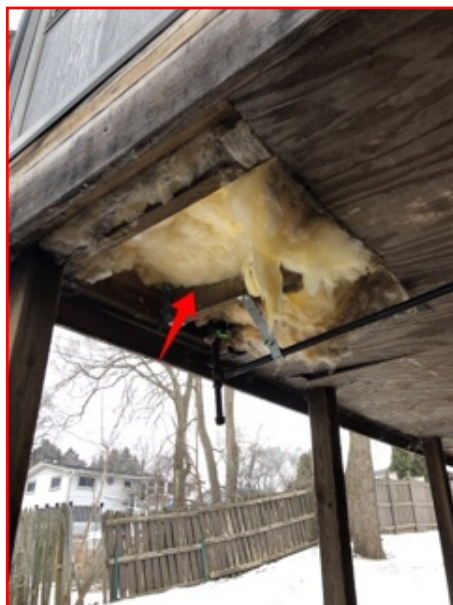
Figure 9-1

Sections of wood plywood are missing under the porch recommend installing plywood to prevent insect and pest infestation.

9) Sections of wood plywood are missing under the porch recommend installing plywood to prevent insect and pest infestation.

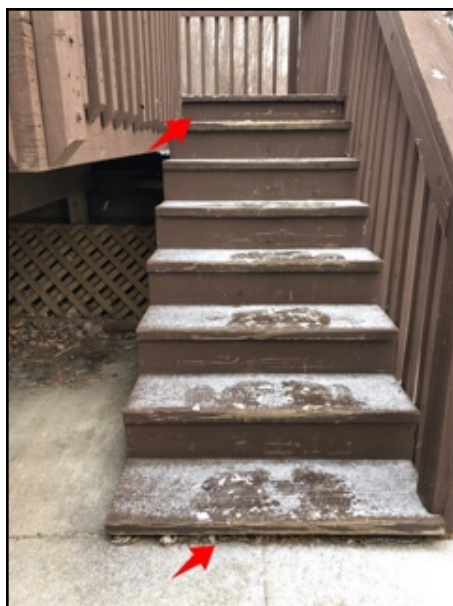
Figure 12-1

Front stoop step shows an irregular step riser heights. Irregular step risers are considered trip hazards. Recommend having a qualified carpenter correct the step structure.

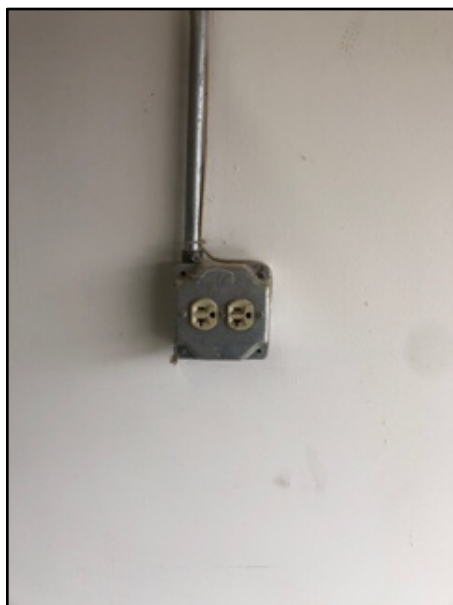
Figure 13-1

**Comment 13:**
All garage outlets are recommended to be converted to GFCI outlets.

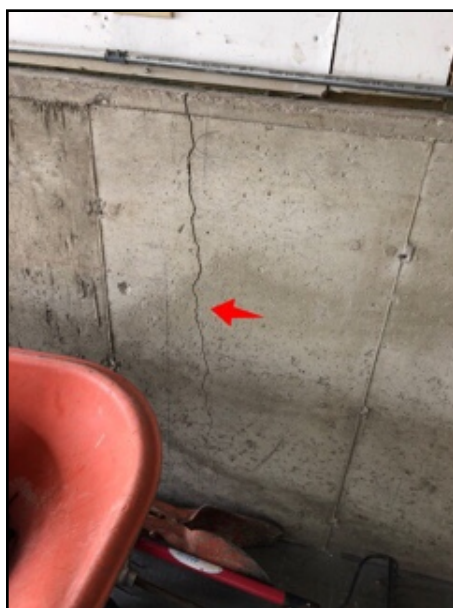
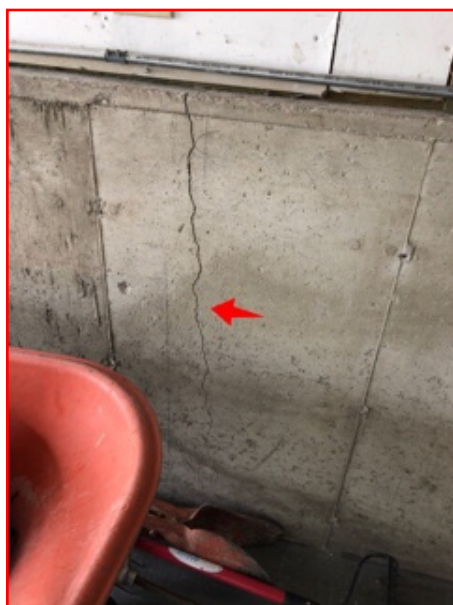
Figure 14-1

Vertical cracks were observed on the garage foundation walls. Some foundation cracking is typical of settlement and or shrinkage and does not usually indicate structural deficiencies. Every crack or opening in the foundation wall or floor is a potential source for moisture entry. We strongly recommend that our client makes an inquiry with the current owner as to whether there has been any moisture, seepage or flooding into the garage. Recommend monitoring the cracks for movement or leaks. If movement or leaks occurs the cracks will be recommended to be repaired.

14) Vertical cracks were observed on the garage foundation walls. Some foundation cracking is typical of settlement and or shrinkage and does not usually indicate structural deficiencies. Every crack or opening in the foundation wall or floor is a potential source for moisture entry. We strongly recommend that our client makes an inquiry with the current owner as to whether there has been any moisture, seepage or flooding into the garage. Recommend monitoring the cracks for movement or leaks. If movement or leaks occurs the cracks will be recommended to be repaired.

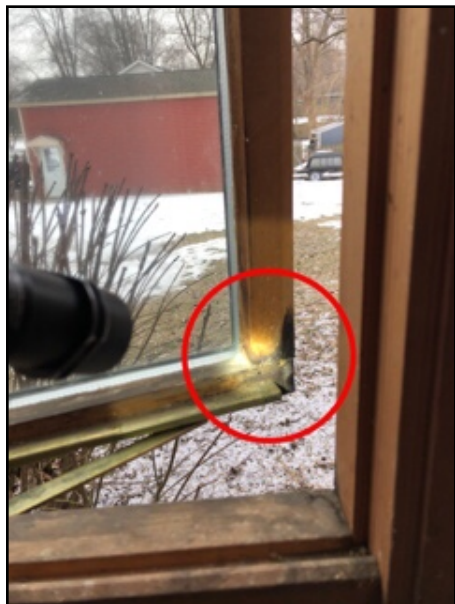
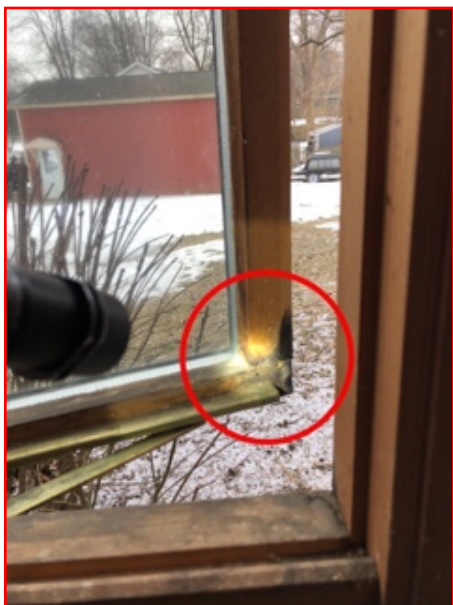
Figure 16-1

Garage left side window frame is rotted and has a failed seal. Recommend having a qualified window contractor correct the window.

15) Garage left side window frame is rotted and has a failed seal. Recommend having a qualified window contractor correct the window.

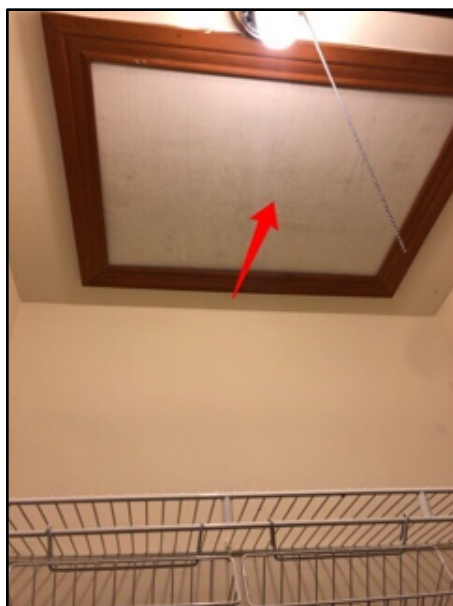
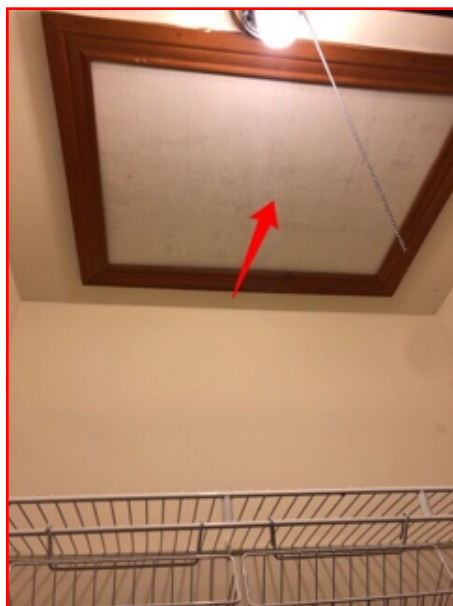
Figure 20-1

Wood hatch for attic access is not fire rated. Recommend installing a fire rated hatch. (Drywall)

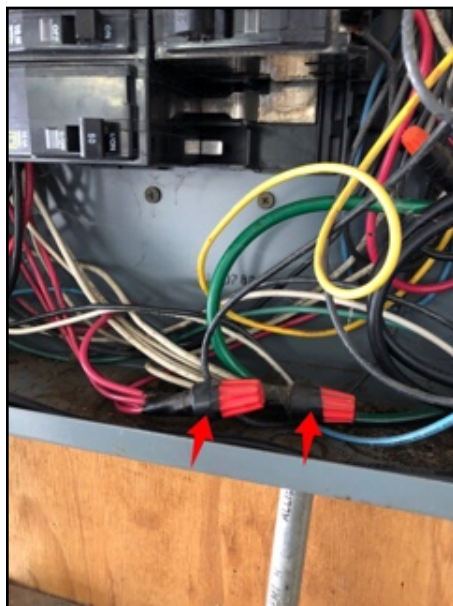
Figure 22-1

The electrical service panel showed several branch circuits wired together with a wire nut connecting to a breaker. It is recommended having branch circuit wires wired to individual breakers to reduce the opportunity of overloading breakers due to multiple loads from addition branch circuits. Recommend having a qualified electrician correct the wiring in the panel.

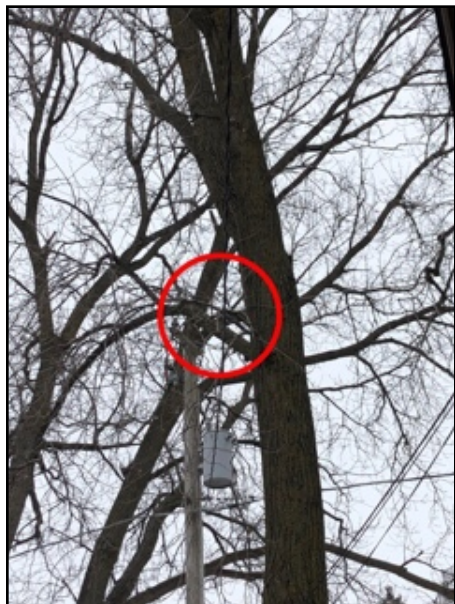
Figure 23-1

Main service wires are rubbing on a tree branch. Recommend trimming the tree branch to prevent the wires from rubbing.

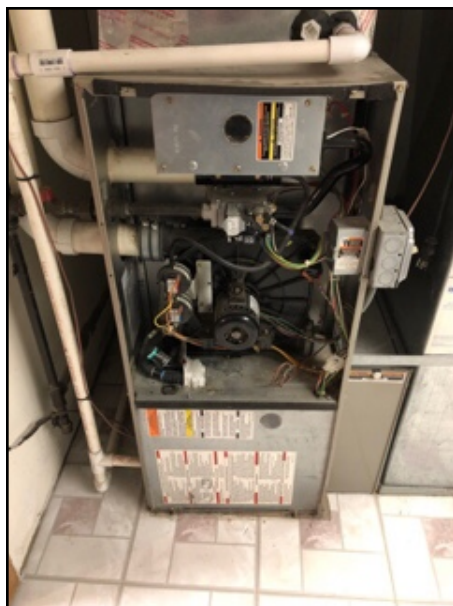
Figure 26-1

HVAC unit appears to have been Mfg. in 2008 and there are no signs of recent service to the HVAC unit. HVAC systems due require routine maintenance as proper operation of all units should be verified prior to closing. Heat exchangers should be inspected and certified by a heating contractor as evaluation of a furnace heat exchanger or a boiler combustion chamber requires dismantling of the unit, including burner removal, and is, therefore, beyond the scope of this inspection. Although the HVAC units were operational at the time of the inspection, further evaluation from a professional HVAC individual is recommended to further evaluate the overall condition of the HVAC units due to no signs of recent service.

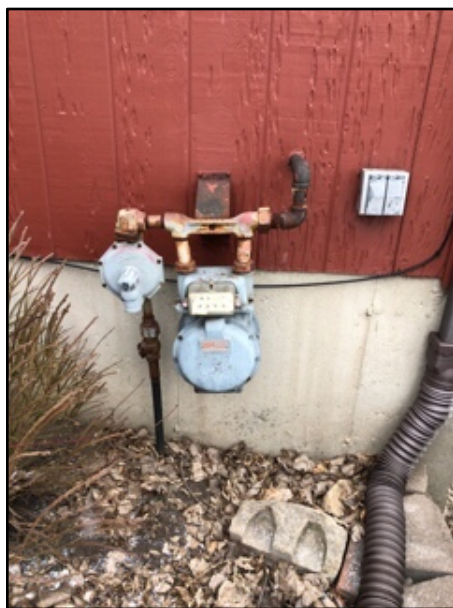
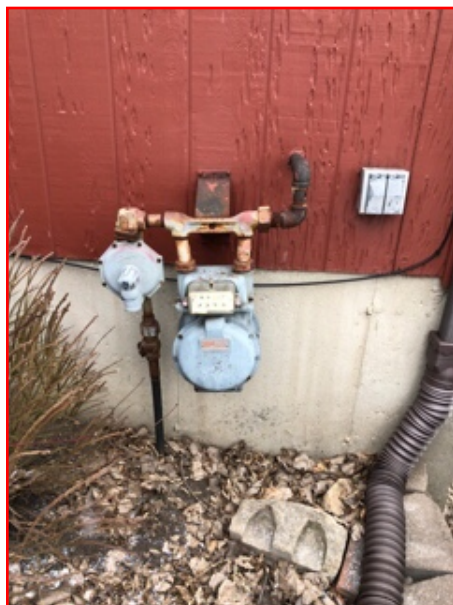
Figure 29-1

A gas leak was observed at the gas meter. Recommend having a qualified plumber correct the leak.

23) A gas leak was observed at the gas meter. Recommend having a qualified plumber correct the leak.

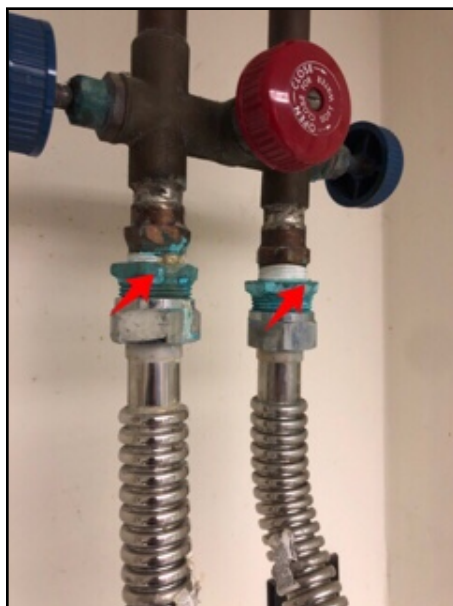
Figure 30-1

Dissimilar metals were observed throughout the home without appropriate fittings. Corrosion is occurring due to dissimilar metals being in contact with each other and not having appropriate fittings installed. Recommend having a qualified plumber correct all affected connections to prevent possible leaks.

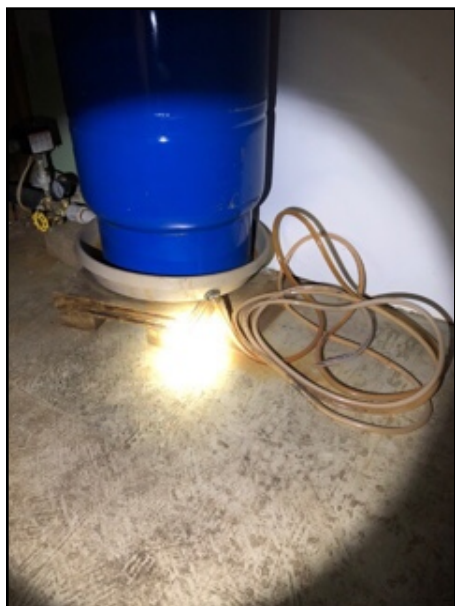
Figure 34-1

The water bladder overflow pan is damaged and is not connected to a floor drain. Recommend replacing the overflow pan and connecting the overflow pan to a floor drain or install a water sensor in the pan.

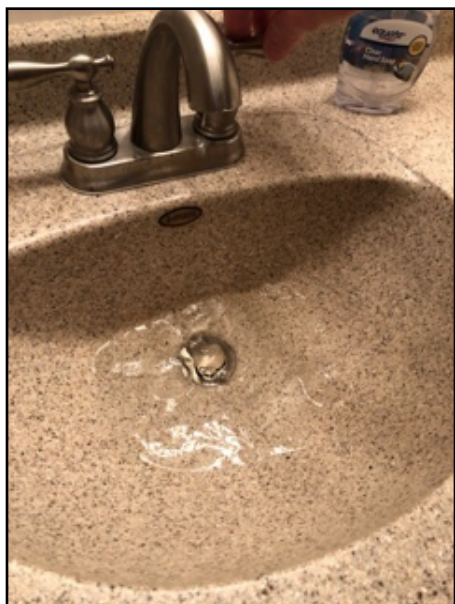
Figure 35-1

Hall bathroom sink has a slow drain as water drains very slowly when water is activated from the faucet. Recommend unclogging the drain connection to allow water to drain as it should.

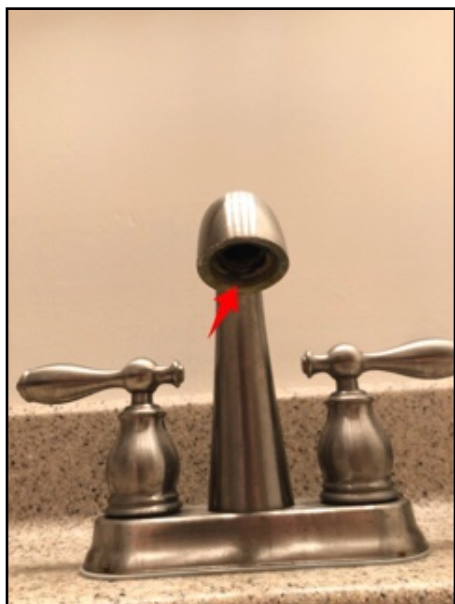
Figure 36-1

Hall bathroom sink faucet is missing the screen hardware. Recommend installing the sink faucet screen hardware to allow for adequate water flow.

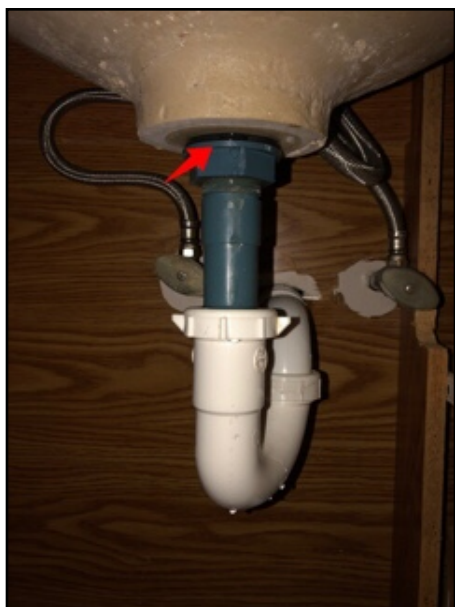
Figure 37-1

Hall bathroom sink drain connection leaks. Repairs are recommended to the sink drain connection to eliminate the water leak.

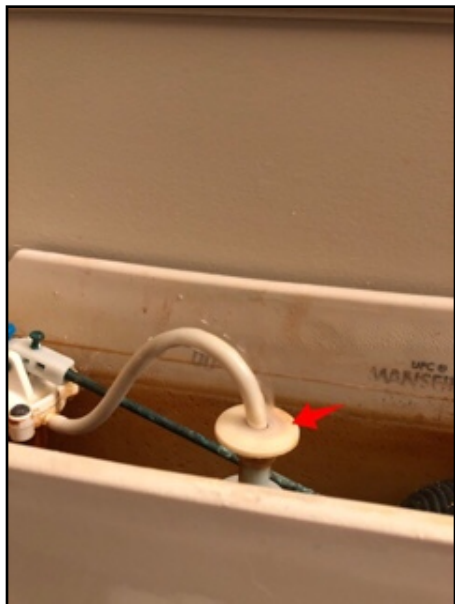
Figure 38-1

Toilet is not filling properly. Water is spraying from the fill tube. Recommend replacing the toilet tank components.

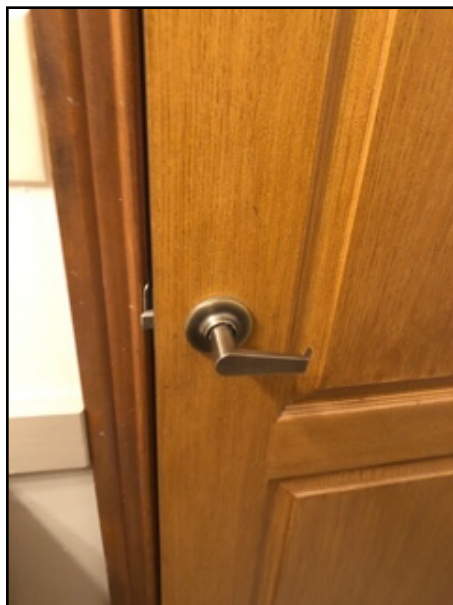
Figure 40-1

Hall bathroom door will not latch when closed, door hardware is recommended to be adjusted to allow the door to close, latch and lock when necessary.

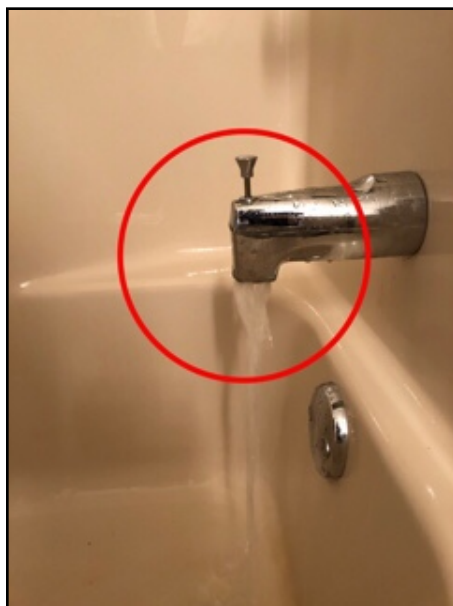
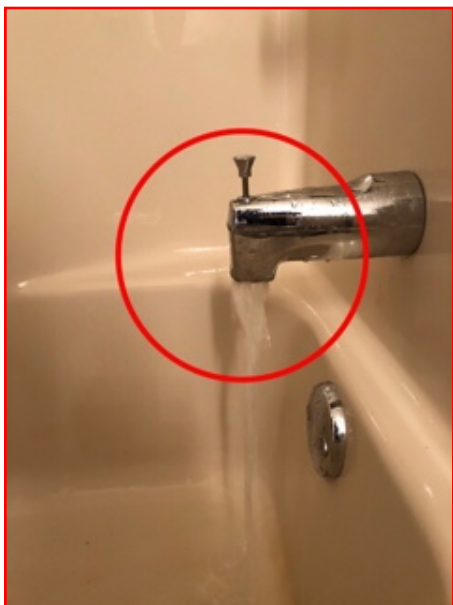
Figure 41-1

Bathroom tub shower diverter is not diverting water completely. Replacement and/or repairs for shower diverter are recommended to allow for proper water pressure from showerhead along with reducing water waste when the shower is activated.

34) Bathroom tub shower diverter is not diverting water completely. Replacement and/or repairs for shower diverter are recommended to allow for proper water pressure from showerhead along with reducing water waste when the shower is activated.

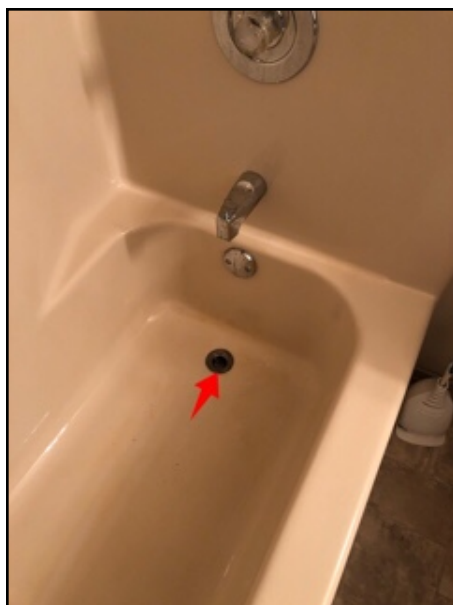
Figure 43-1

Tub stopper is missing. Recommend installing a tub stopper to allow the tub to hold water when necessary.

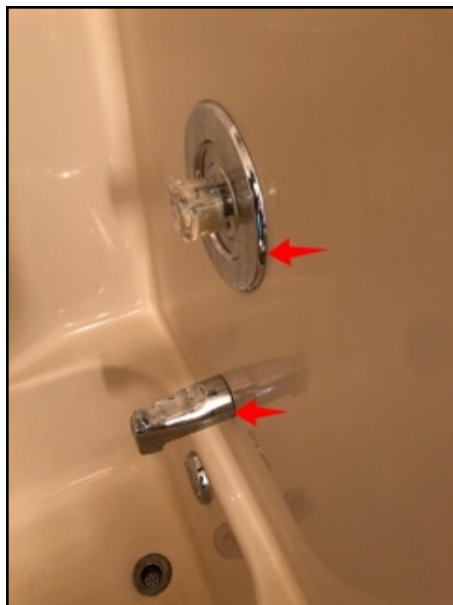
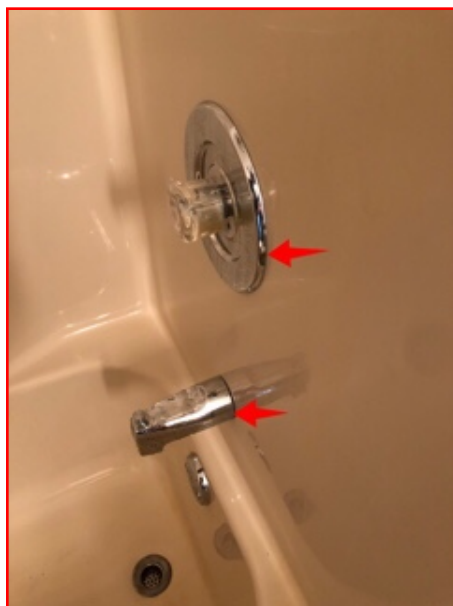
Figure 46-1

Recommend caulking tub faucet fixtures to the wall to prevent possible seepage behind the tile wall when the shower is in use.

39) Recommend caulking tub faucet fixtures to the wall to prevent possible seepage behind the tile wall when the shower is in use.

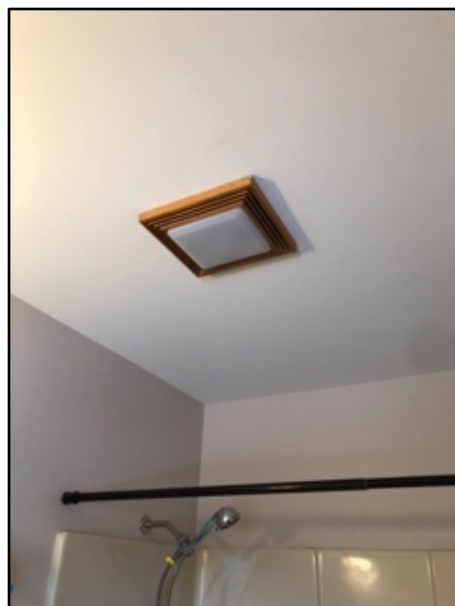
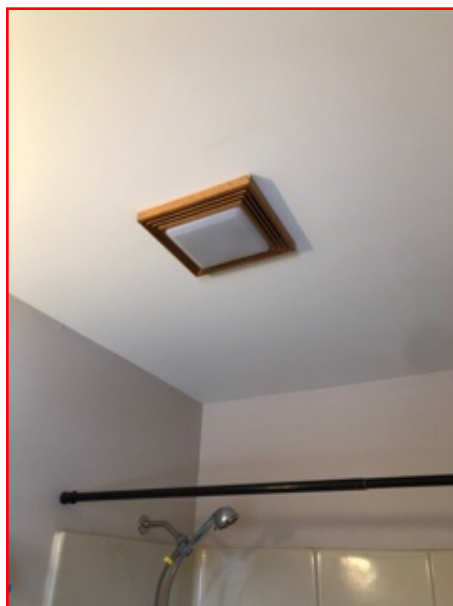
Figure 48-1

Master bathroom ventilation fan is noisy when in use. Fan is at or nearing the end of its serviceable life. Replacement is recommended.

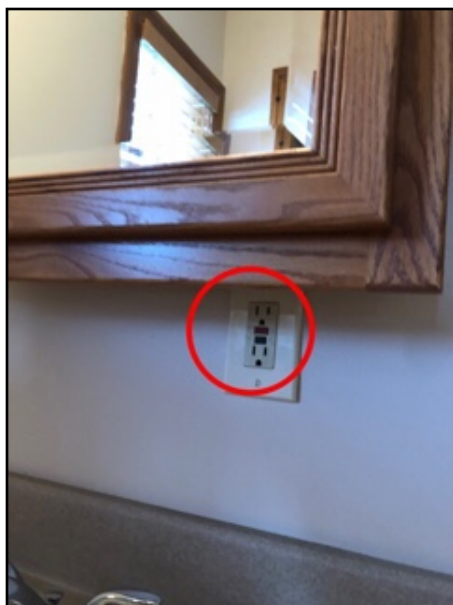
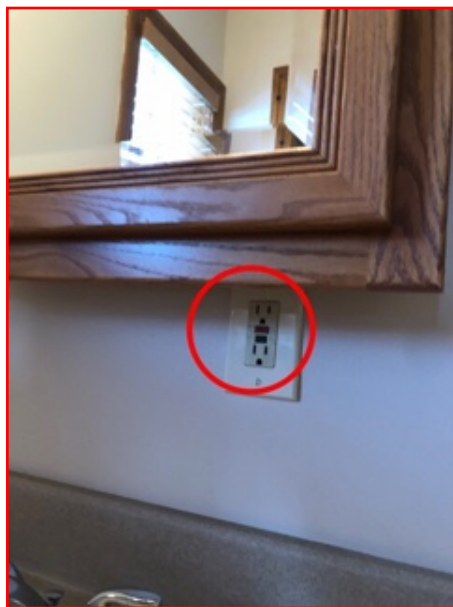
Figure 49-1

Master bathroom GFCI receptacle was not functioning properly. When testing the GFCI receptacle at the receptacle and with a circuit tester, when attempting to trip and reset the GFCI receptacle, the GFCI receptacle would not trip. Replacement is recommended to allow the GFCI receptacle to trip when necessary to reduce the possibility of electrical shock hazards.

42) Master bathroom GFCI receptacle was not functioning properly. When testing the GFCI receptacle at the receptacle and with a circuit tester, when attempting to trip and reset the GFCI receptacle, the GFCI receptacle would not trip. Replacement is recommended to allow the GFCI receptacle to trip when necessary to reduce the possibility of electrical shock hazards.

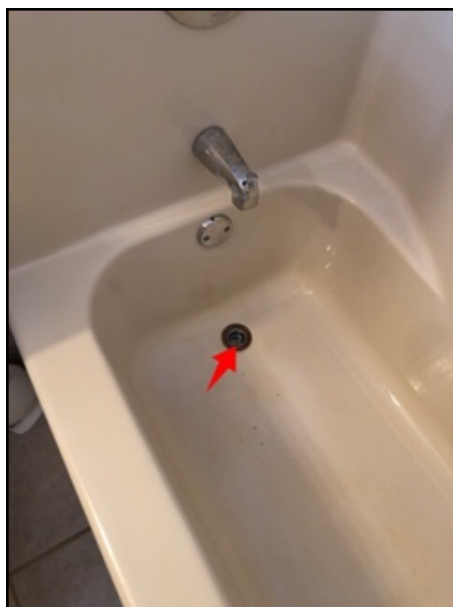
Figure 51-1

Tub stopper is missing. Recommend installing a tub stopper to allow the tub to hold water when necessary.

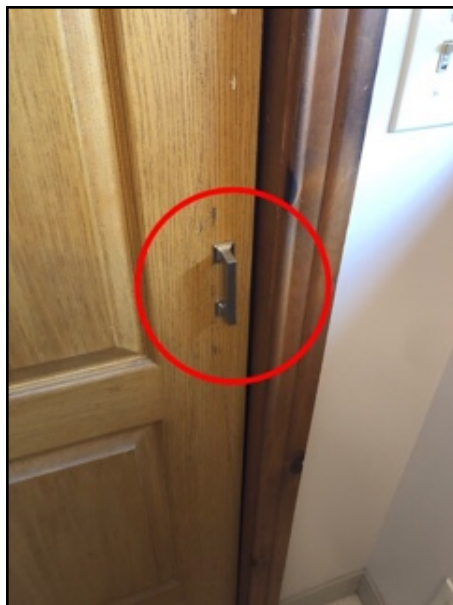
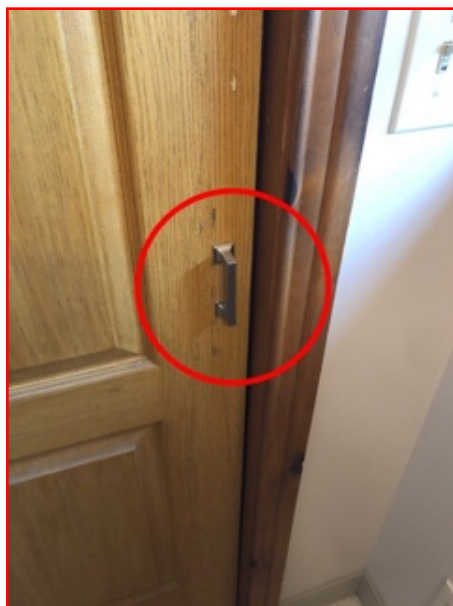
Figure 54-1

The pocket door is missing latch lock hardware to lock the door. Recommend installing lock hardware for the door.

47) The pocket door is missing latch lock hardware to lock the door. Recommend installing lock hardware for the door.

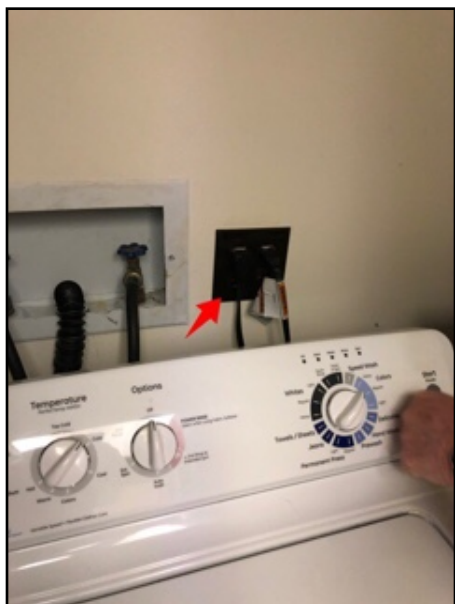
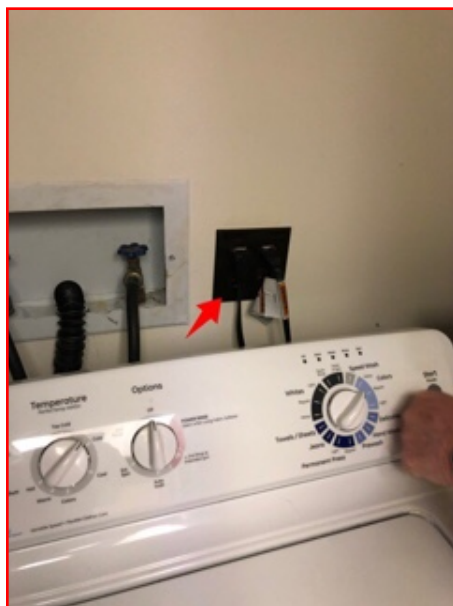
Figure 58-1

51) Laundry room electrical receptacles are non-GFCI receptacles. It is recommended to have GFCI receptacles installed within six feet of any source of water. Affected electrical receptacles are recommended to be replaced with a GFCI receptacles.

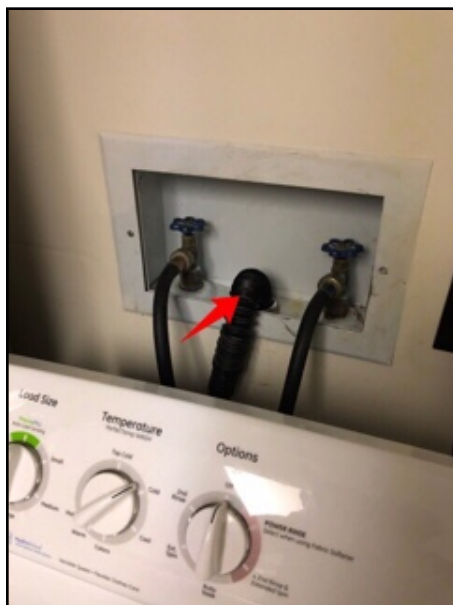
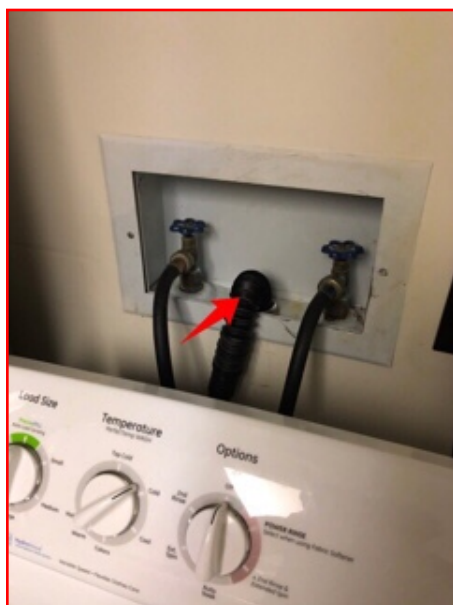
Figure 59-1

The clothes washer drain line is recommended to be secured to the wall or water supply lines to prevent the drain hose from coming out of the drain when in use.

52) The clothes washer drain line is recommended to be secured to the wall or water supply lines to prevent the drain hose from coming out of the drain when in use.

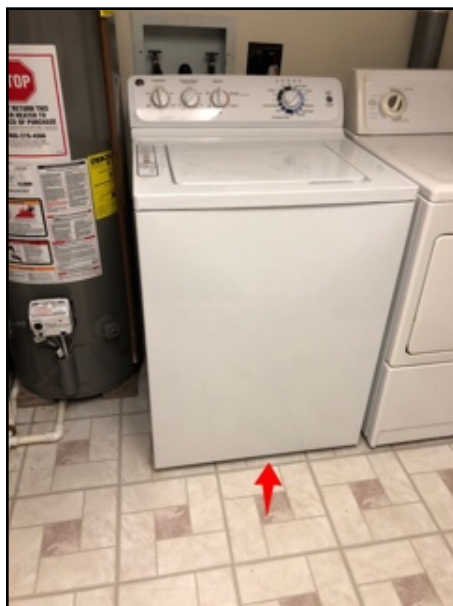
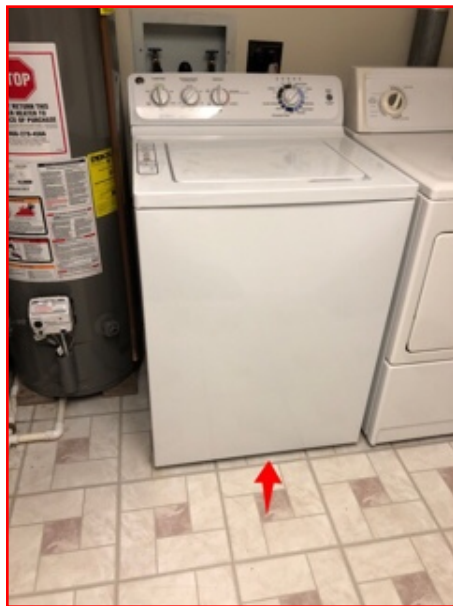
Figure 60-1

Clothes washer unit was missing an overflow pan. Although it is not uncommon to see this item not installed, an overflow pan is recommended to be installed under the unit and if possible connected to a floor drain to reduce the opportunity of water seepage to adjacent floor if the washer leaks. If no drain is present then an electrical sensor/alarm can be installed to turn off the washer if it leaks.

53) Clothes washer unit was missing an overflow pan. Although it is not uncommon to see this item not installed, an overflow pan is recommended to be installed under the unit and if possible connected to a floor drain to reduce the opportunity of water seepage to adjacent floor if the washer leaks. If no drain is present then an electrical sensor/alarm can be installed to turn off the washer if it leaks.

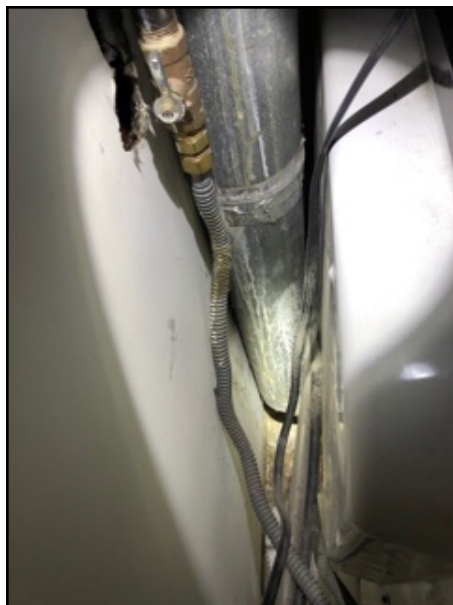
Figure 62-1

The dryer vent is slightly detached at the back of the dryer. Recommend securing the dryer vent to the dryer.

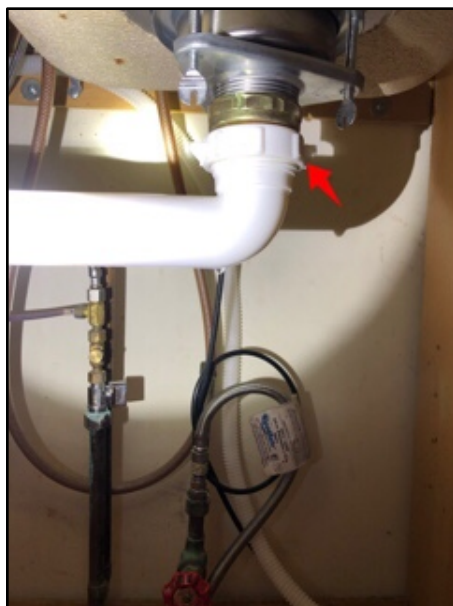
Figure 63-1

Right side sink drain connection leaks as water was observed dripping along with water observed on the floor of the cabinet. Repairs are recommended to eliminate the water leak and possible water damage to base cabinet unit.

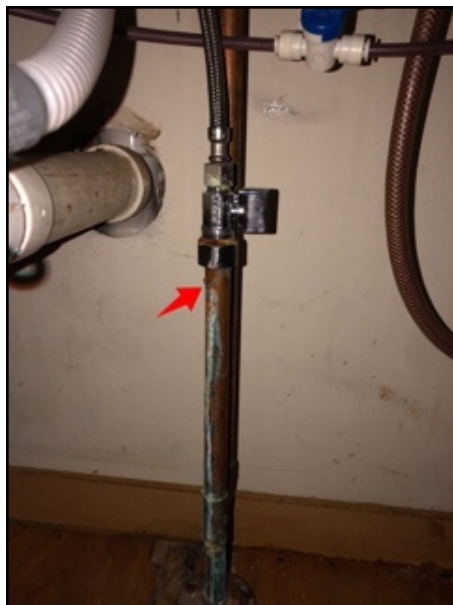
Figure 65-1

Hot water supply valve connection leaks. Recommend having a qualified plumber correct the leak.

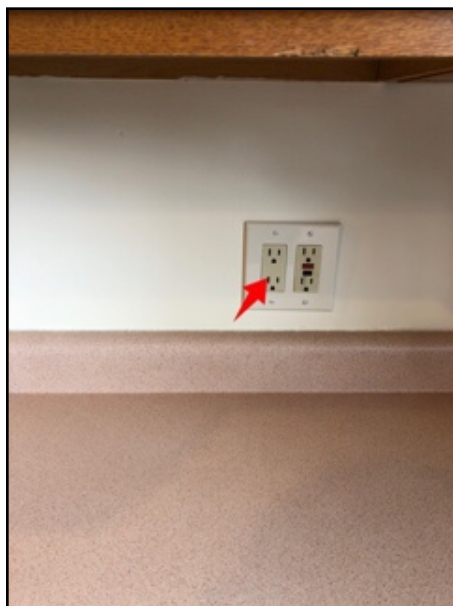
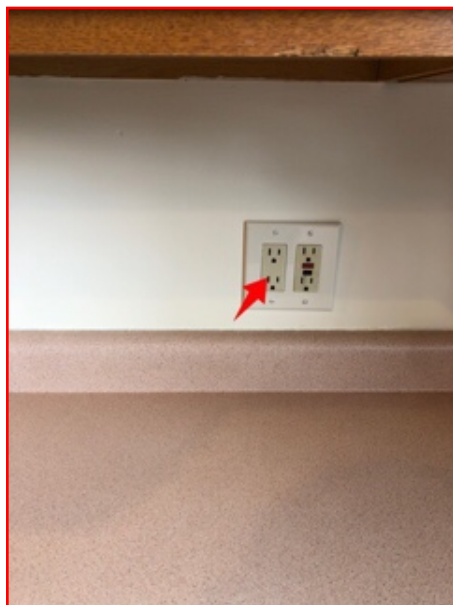
Figure 68-1

Electrical receptacles are non-GFCI receptacles. It is recommended to have GFCI receptacles installed within six feet of any source of water. Affected electrical receptacles are recommended to be replaced with a GFCI receptacle.(all kitchen outlets)

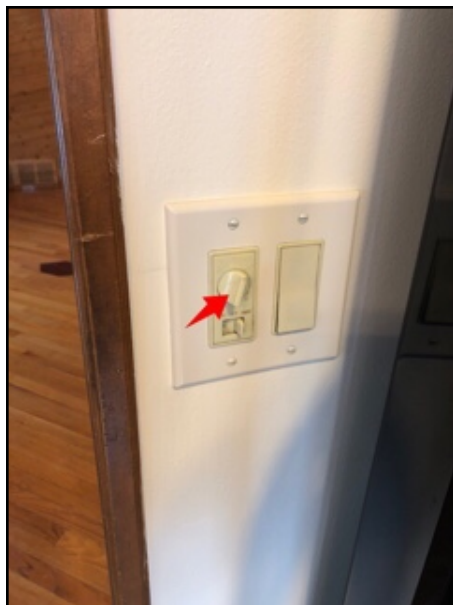
Figure 70-1

The fan wall switch is damaged/inoperable. Replacement of the switch is recommended.

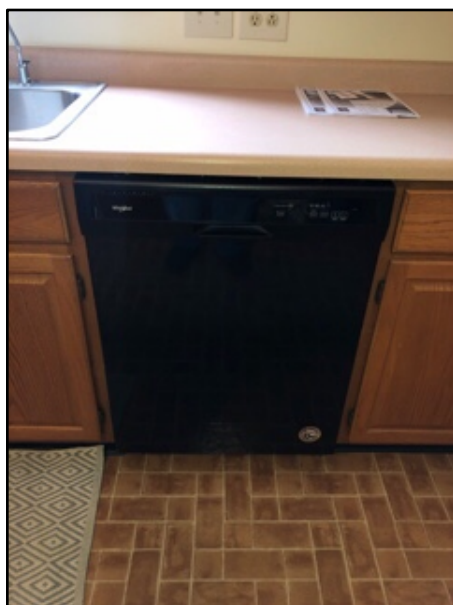
Figure 71-1

The seller disclosed the dishwasher (new) is not working properly and is to be repaired. Recommend verifying the dishwasher is in proper working condition.

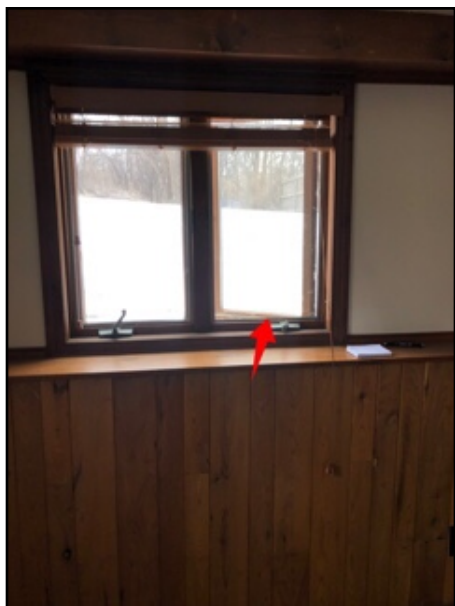
Figure 73-1

Basement north left hand side window crank is stripped and the window will not close on its own. Repairs are recommended to allow the window to open and close properly.

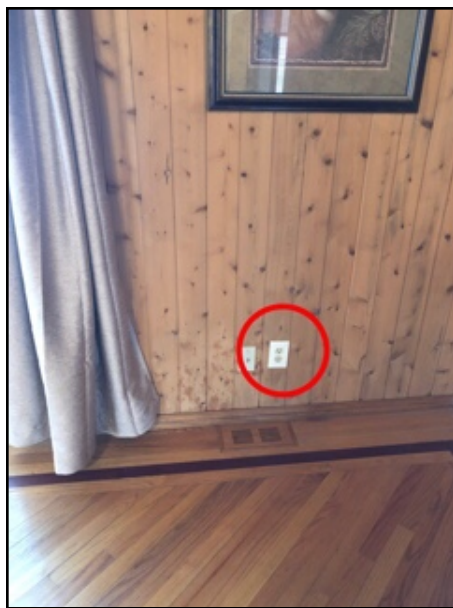
Figure 76-1

Family room west wall right side outlet was a loose wire connection. When testing the outlet the tester was flickering. Recommend having a qualified electrician correct the wiring to the outlet.

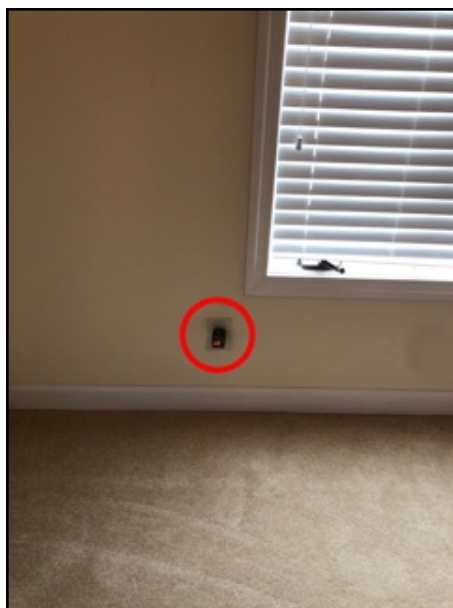
Figure 79-1

Northwest bedroom north wall outlet is not wired properly. When testing the outlet with a circuit tester the outlet shows to be wired reversed polarity. Recommend having a qualified electrician correct the wiring to the outlet.

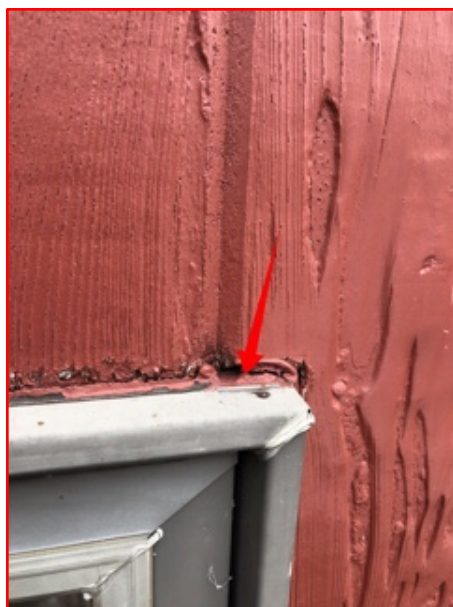
Figure 1-1

1) Protecting the home from possible water and insect penetration is very important. It is recommended that all gaps and openings the exterior siding, windows, doors, plumbing, electrical, exhaust vents, light fixtures and all other visible points of entry be properly sealed/caulked.

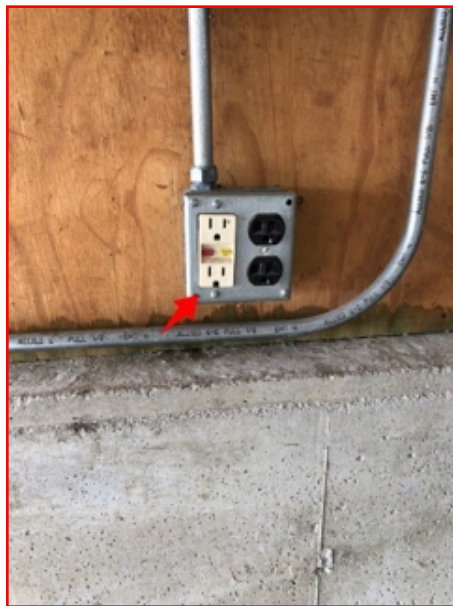
Figure 17-1

Garage GFCI receptacle was not functioning properly. When testing the GFCI receptacle at the receptacle and with a circuit tester, when attempting to trip and reset the GFCI receptacle, the GFCI receptacle would not trip. Replacement is recommended to allow the GFCI receptacle to trip when necessary to reduce the possibility of electrical shock hazards.

16) Garage GFCI receptacle was not functioning properly. When testing the GFCI receptacle at the receptacle and with a circuit tester, when attempting to trip and reset the GFCI receptacle, the GFCI receptacle would not trip. Replacement is recommended to allow the GFCI receptacle to trip when necessary to reduce the possibility of electrical shock hazards.

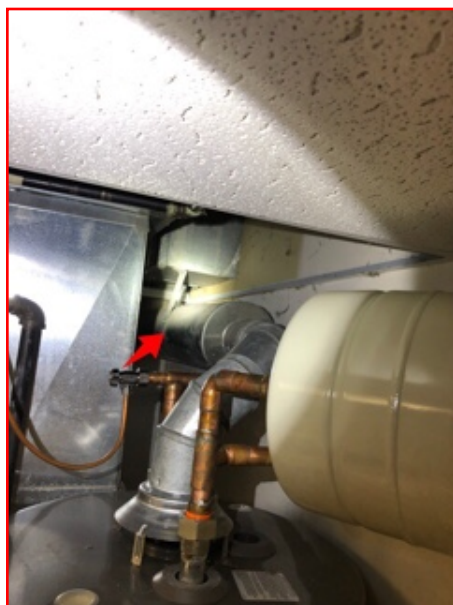
Figure 33-1

26) Water heater flue pipe showed an inadequate slope of the flue to the chimney stack. It is recommended to have a $\frac{1}{4}$ inch per foot elevated slope to the chimney stack to reduce the opportunity of spillage (downdraft) which may allow CO to vent back into the interior due to downward slope to stack. Recommend having a qualified plumber correct the flue pipe.

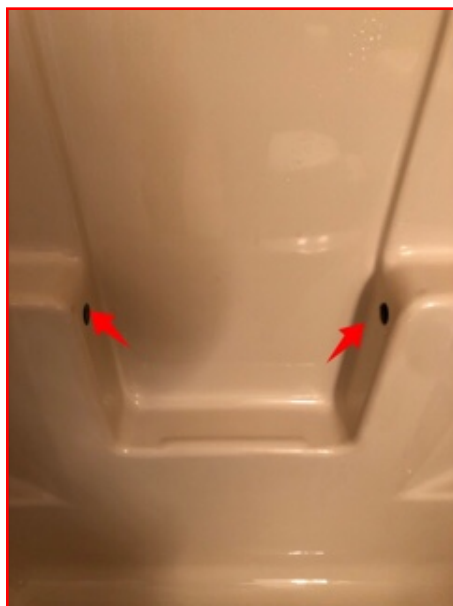
Figure 44-1

37) Tub handle is missing. Recommend installing the handle or capping off the openings to prevent water infiltration behind the walls.

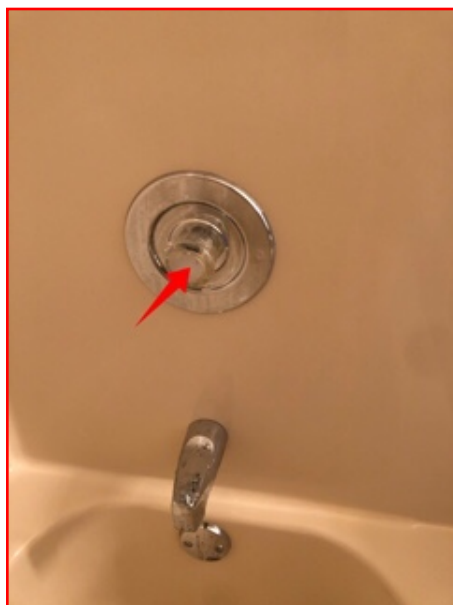
Figure 45-1

38) Bathroom tub faucet hot and cold are reversed. Recommend reversing the hot and cold distribution lines and/or faucet mechanism to allow for correct sides of water temperature for the tub faucet.

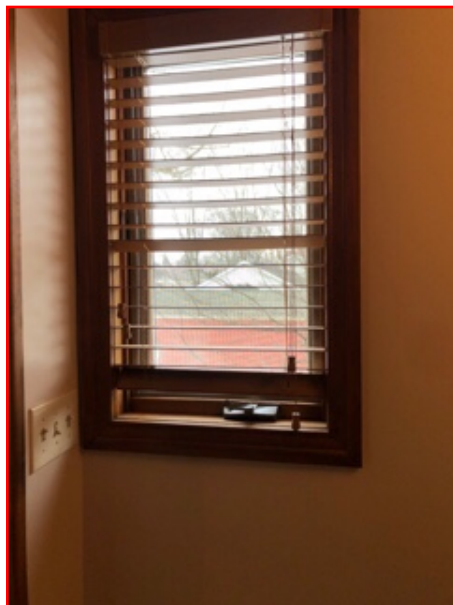
Figure 55-1

48) The bathroom window is recommended to be replaced with a tempered glass to prevent possible personal injury if a fall occurs in the bathroom.
