Home Inspection Report

123 Sample St.

Chicago, IL

Inspected on Fri, Mar 8 2019 at 10:00 AM

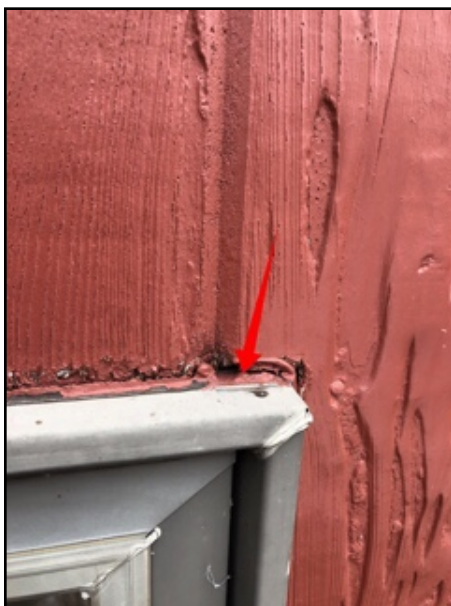
Figure 1-1

Protecting the home from possible water and insect penetration is very important. It is recommended that all gaps and openings the exterior siding, windows, doors, plumbing, electrical, exhaust vents, light fixtures and all other visible points of entry be properly sealed/caulked.

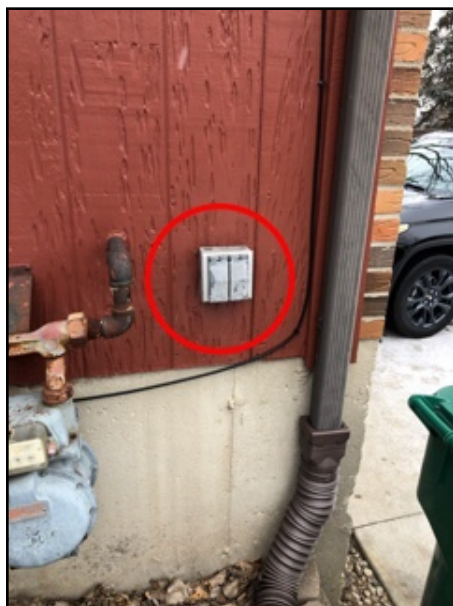
Figure 2-1

Exterior electrical receptacles are non-GFCI receptacles. It is recommended to have GFCI receptacles installed within six feet of any source of water. Affected receptacles are recommended to be replaced with GFCI receptacles or GFCI breakers.

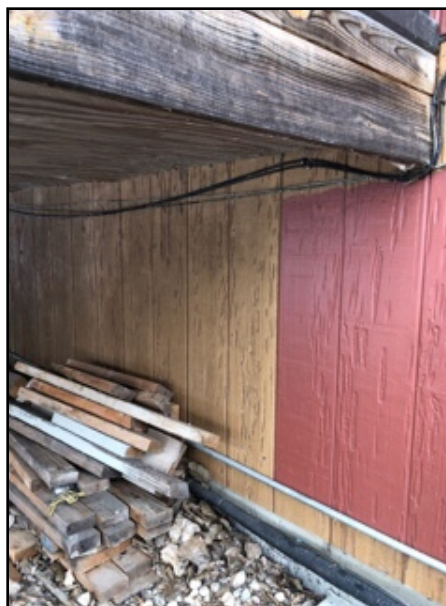
Figure 8-2

Recommend painting all unpainted sections of the siding to prevent possible rot.

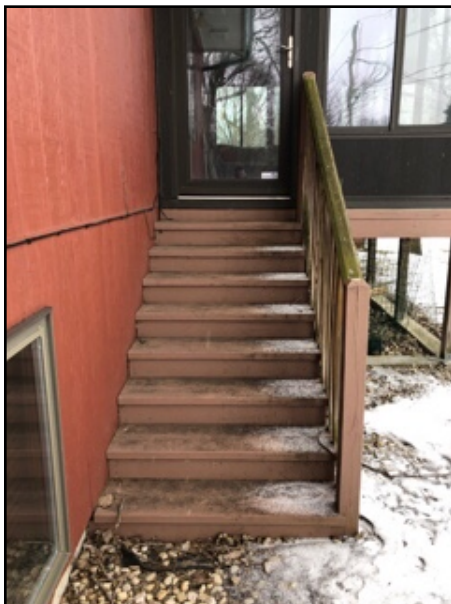
Figure 10-1

**Comment 10:**
Front and rear step structures are missing handrails. Recommend installing graspable handrails to prevent possible trip hazards.

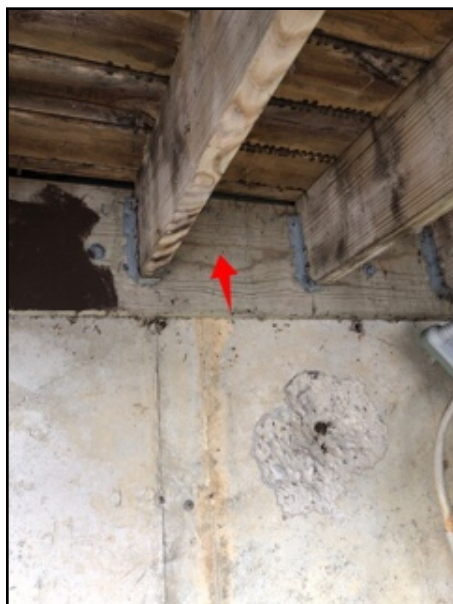
Figure 11-1

**Comment 11:**
The front porch ledger board is not bolted properly and is missing flashing. It is recommended to have the ledger bolts installed in a staggered pattern. It is recommended to have flashing installed on the ledger board to prevent rot and possible ledger board failure. Recommend having a qualified deck contractor properly bolt and flash the ledger board.

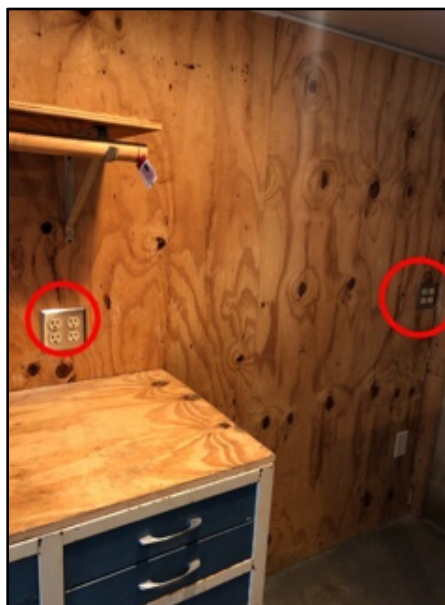
Figure 13-2

**Comment 13:**
All garage outlets are recommended to be converted to GFCI outlets.

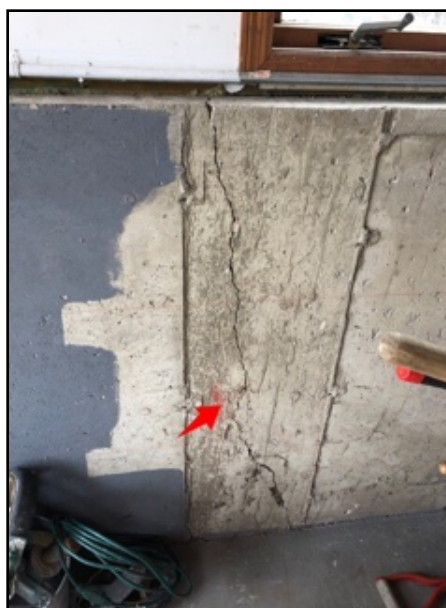
Figure 14-2

Vertical cracks were observed on the garage foundation walls. Some foundation cracking is typical of settlement and or shrinkage and does not usually indicate structural deficiencies. Every crack or opening in the foundation wall or floor is a potential source for moisture entry. We strongly recommend that our client makes an inquiry with the current owner as to whether there has been any moisture, seepage or flooding into the garage. Recommend monitoring the cracks for movement or leaks. If movement or leaks occurs the cracks will be recommended to be repaired.

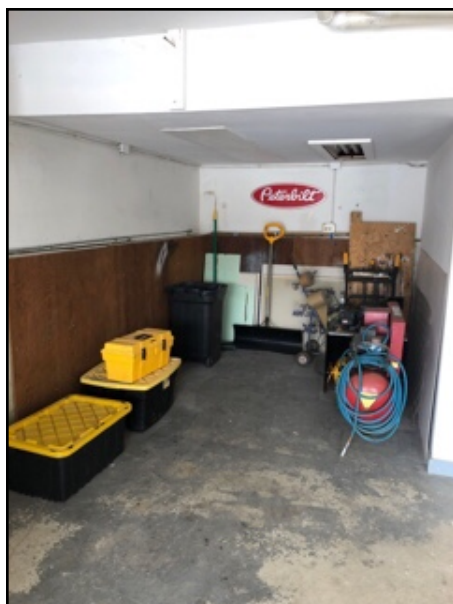
Figure 15-1

Garage inspection was limited due to areas that were blocked with wall and ceiling coverings along with stored items that did not allow the inspector to evaluate the overall condition of these areas. Only the readily visible portions of the garage structure were observed. Surfaces hidden behind finishes and stored items cannot be observed by the inspector.

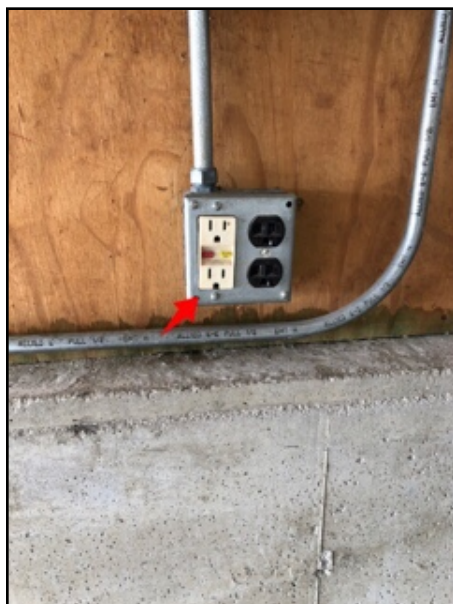
Figure 17-1

Garage GFCI receptacle was not functioning properly. When testing the GFCI receptacle at the receptacle and with a circuit tester, when attempting to trip and reset the GFCI receptacle, the GFCI receptacle would not trip. Replacement is recommended to allow the GFCI receptacle to trip when necessary to reduce the possibility of electrical shock hazards.

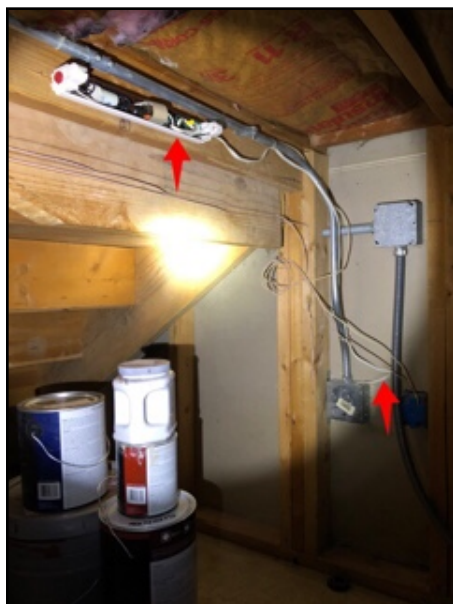
Figure 24-1

The under stairs light is not wired properly (illegal wiring). Recommend removing the light and wiring. Recommend having a qualified electrician wire and install a light fixture properly.

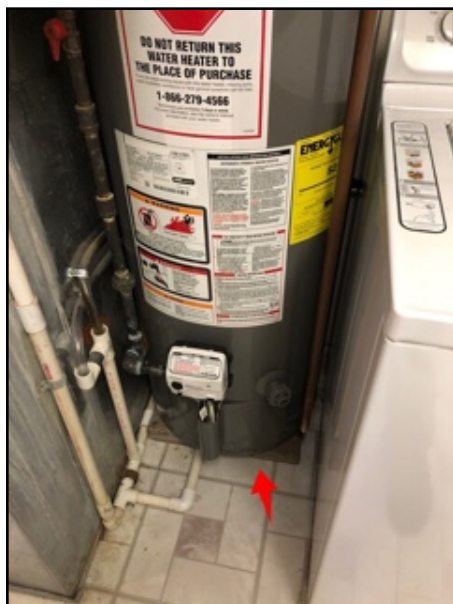
Figure 32-1

The water heater was missing an overflow pan. Although it is not uncommon to see this item not installed, an overflow pan is recommended to be installed under the water heater and if possible connected to a floor drain to reduce the opportunity of water seepage to adjacent floor if the water heater leaks. If no drain is present then an electrical sensor/alarm can be installed to shut down the water heater if it leaks.

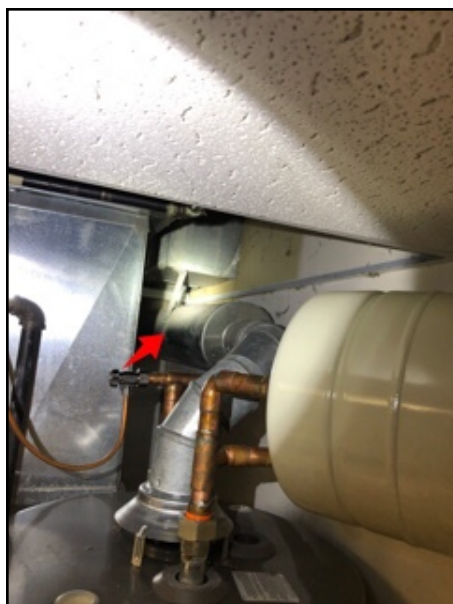
Figure 33-1

Water heater flue pipe showed an inadequate slope of the flue to the chimney stack. It is recommended to have a $\frac{1}{4}$ inch per foot elevated slope to the chimney stack to reduce the opportunity of spillage (downdraft) which may allow CO to vent back into the interior due to downward slope to stack. Recommend having a qualified plumber correct the flue pipe.

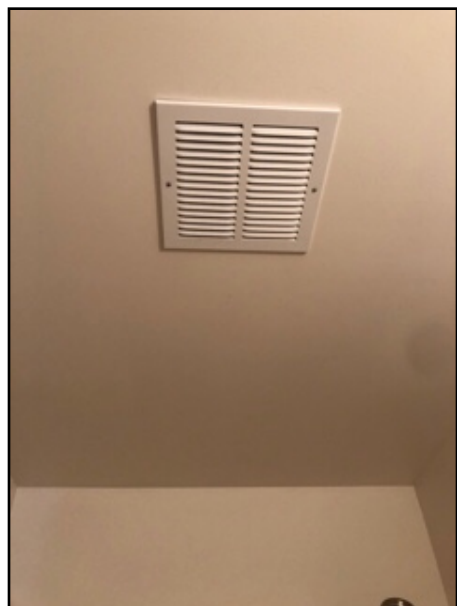
Figure 39-1

Hall bathroom ventilation fan is noisy when in use. Fan is at or nearing the end of its serviceable life. Replacement is recommended.

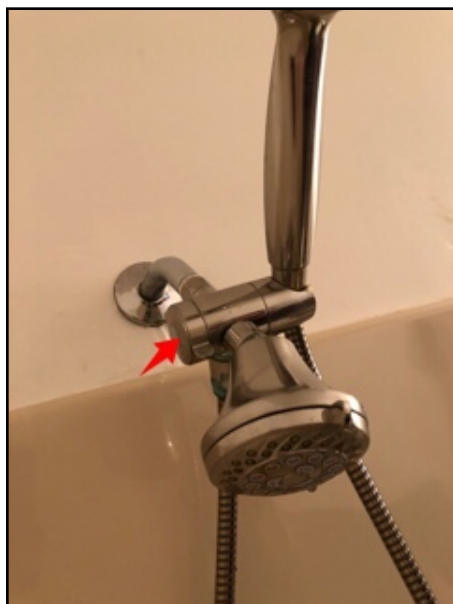
Figure 42-1

The shower head diverter is inoperable as both shower heads run at the same time. Shower head pressure is extremely low due to the faucet diverter not diverting completely. Recommend having a qualified plumber correct the diverter and replace the shower head.

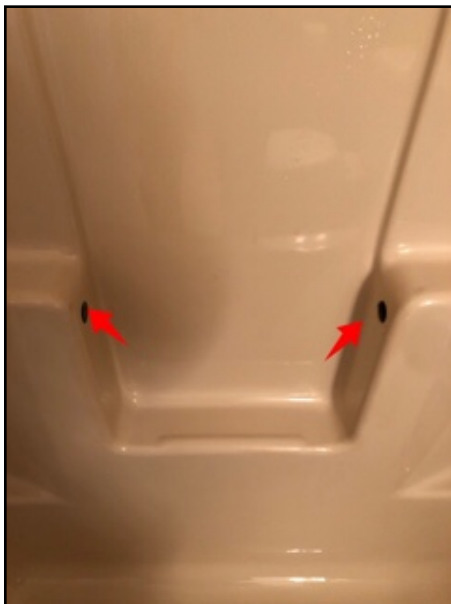
Figure 44-1

**Comment 44:**
Tub handle is missing. Recommend installing the handle or capping off the openings to prevent water infiltration behind the walls.

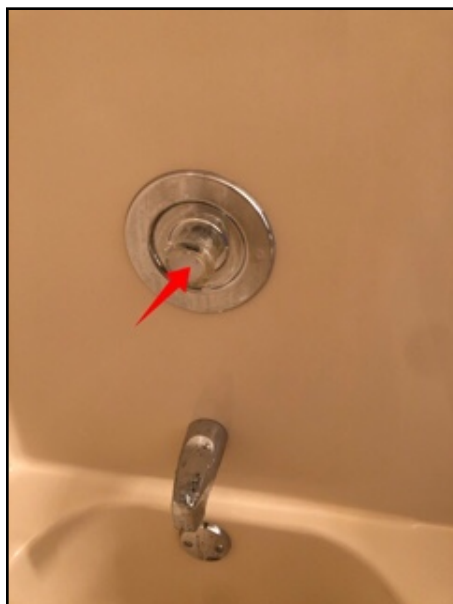
Figure 45-1

**Comment 45:**
Bathroom tub faucet hot and cold are reversed. Recommend reversing the hot and cold distribution lines and/or faucet mechanism to allow for correct sides of water temperature for the tub faucet.

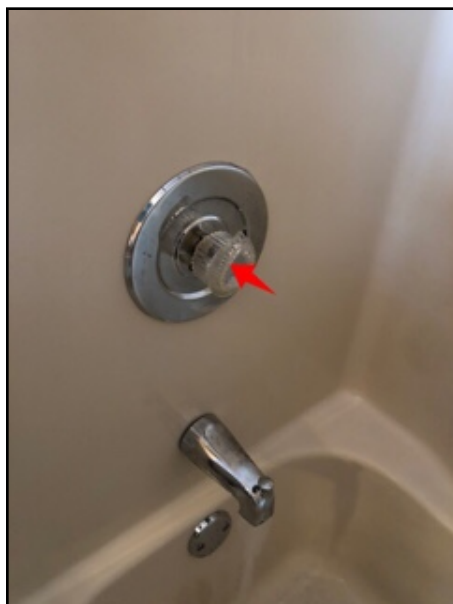
Figure 50-1

Tub faucet handle is hard to turn on and off. The faucet handle does not stop at max hot or cold. Replacement of the faucet hardware is recommended.

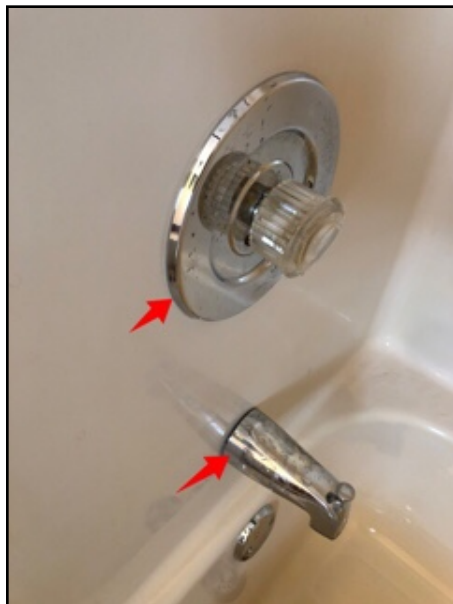
Figure 52-1

Recommend caulking tub faucet fixtures to the wall to prevent possible seepage behind the tile wall when the shower is in use.

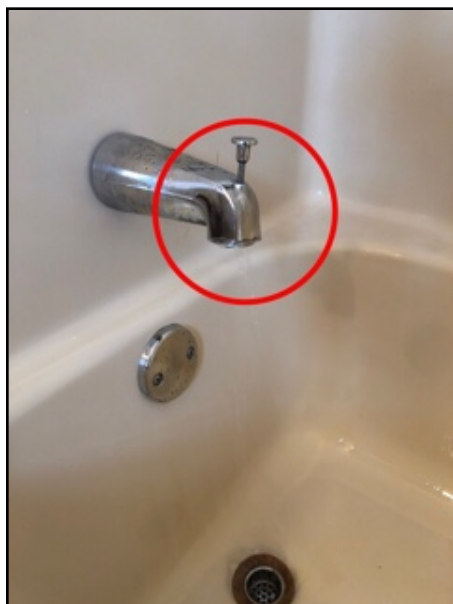
Figure 53-1

Bathroom tub shower diverter is not diverting water completely. Replacement and/or repairs for shower diverter are recommended to allow for proper water pressure from showerhead along with reducing water waste when the shower is activated.

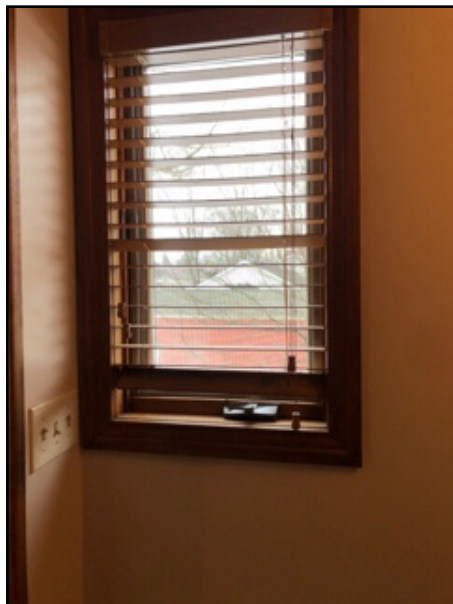
Figure 55-1

The bathroom window is recommended to be replaced with a tempered glass to prevent possible personal injury if a fall occurs in the bathroom.

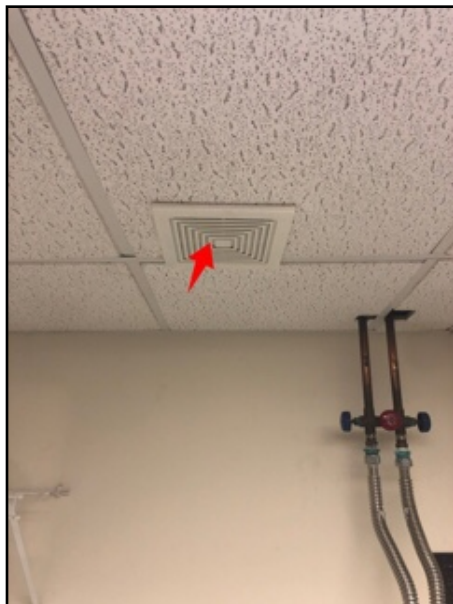
Figure 56-1

Basement bathroom ventilation fan is noisy when in use. Fan is at or nearing the end of its serviceable life. Replacement is recommended.

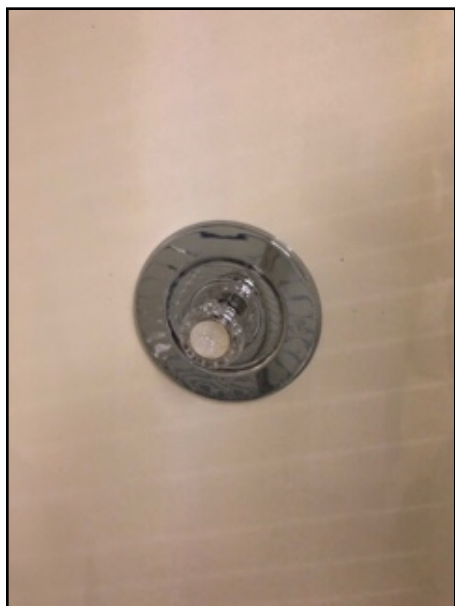
Figure 57-1

Bathroom shower faucet hot and cold are reversed. Recommend reversing the hot and cold distribution lines and/or faucet mechanism to allow for correct sides of water temperature for the showerhead.

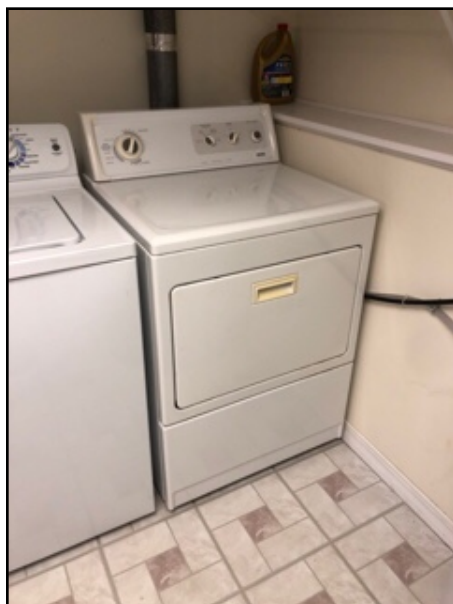
Figure 61-1

Dryer is vibrating when in use(out of balance). Recommend having a qualified appliance contractor evaluate and determine repairs necessary. Replacement of the dryer may be necessary.

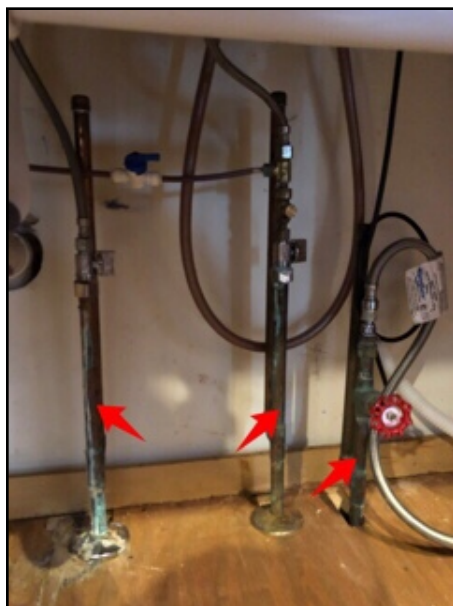
Figure 64-1

Water pipes are loose under the sink. Recommend securing the pipes to the wall to prevent excessive movement when in use.

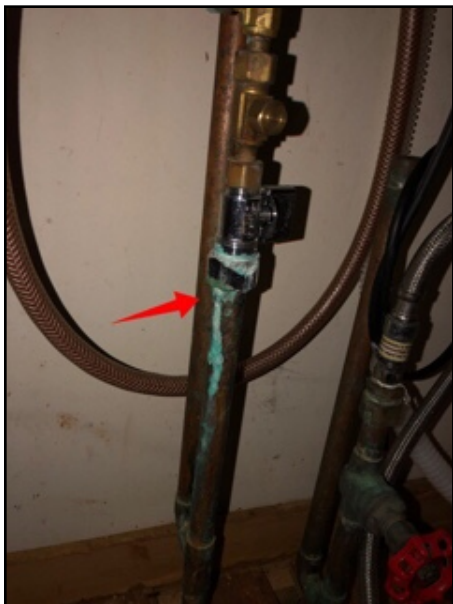
Figure 66-1

The kitchen cold water supply valve connection has a pine hole leak. Recommend having a qualified plumber correct the leak.

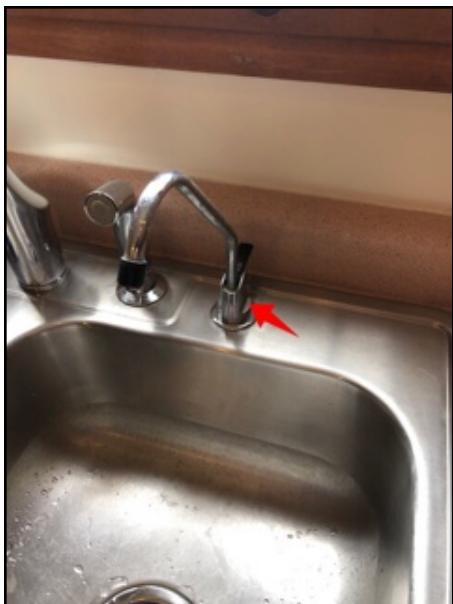
Figure 67-1

The small faucet is not connected to a water source and is inoperable.

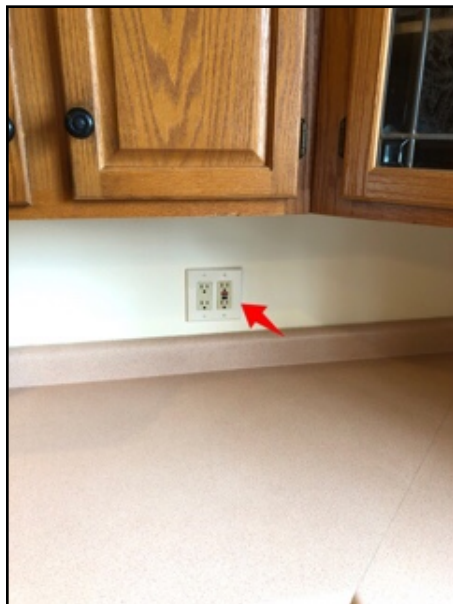
Figure 69-1

Kitchen GFCI receptacle was not functioning properly. When testing the GFCI receptacle at the receptacle and with a circuit tester, when attempting to trip and reset the GFCI receptacle, the GFCI receptacle would not trip. Replacement is recommended to allow the GFCI receptacle to trip when necessary to reduce the possibility of electrical shock hazards.

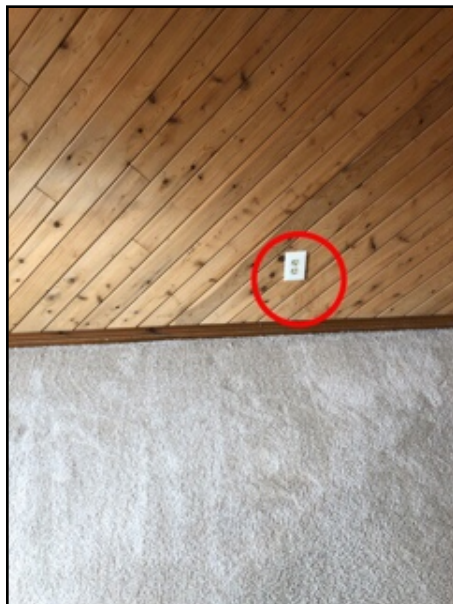
Figure 77-1

Master bathroom south wall right side outlet is loose. Recommend securing the outlet to prevent excessive movement when in use.

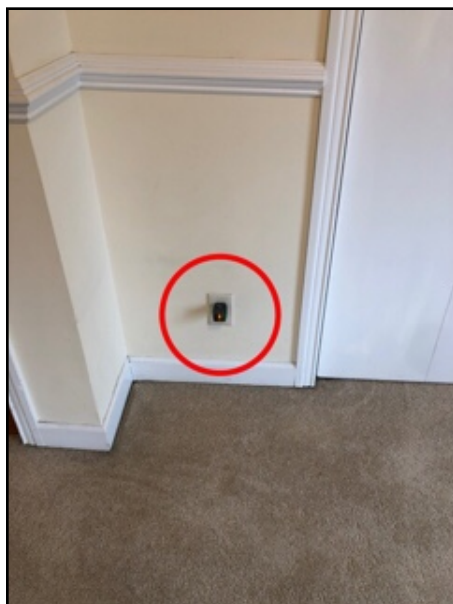
Figure 78-1

The northeast bedroom west wall electrical receptacle is a non-grounded outlet. A grounded outlet introduces a shock path to the ground. A non grounded receptacle does not have the shock path to ground. Affected receptacle is recommended to be grounded to reduce the opportunity of appliance failure and potential shock hazards if power surges occur. Recommend having a qualified electrician correct the affected outlet.

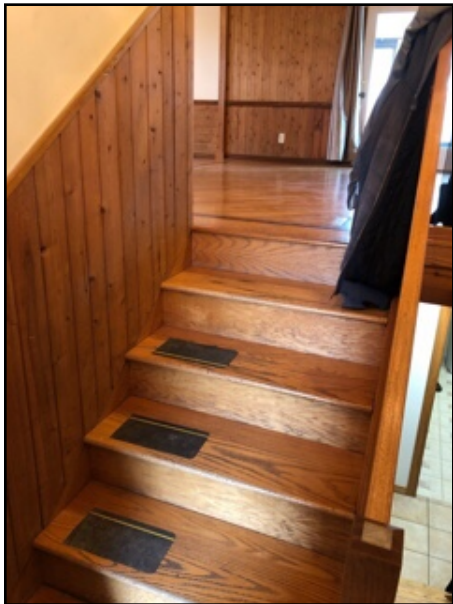
Figure 80-1

- ⚠ Comment 80:
Front entry steps is missing a graspable handrail. Recommend installing a graspable handrail to prevent possible trip hazards.

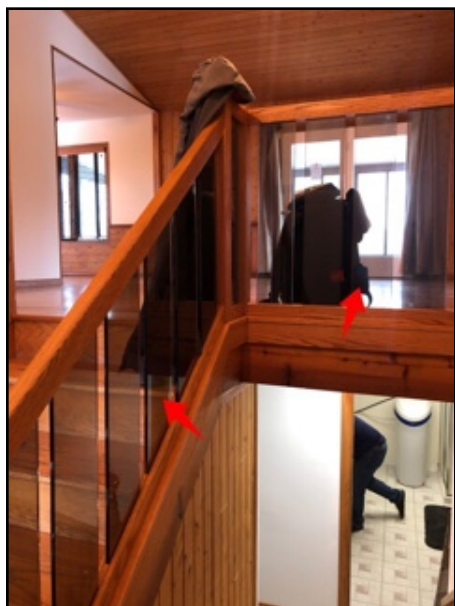
Figure 81-1

-
- ⚠ Comment 81:
Railings to the second level are too low and considered hazardous. Railings are recommended to be at least 36" above the floor. Recommend having a qualified carpenter correct the railings.

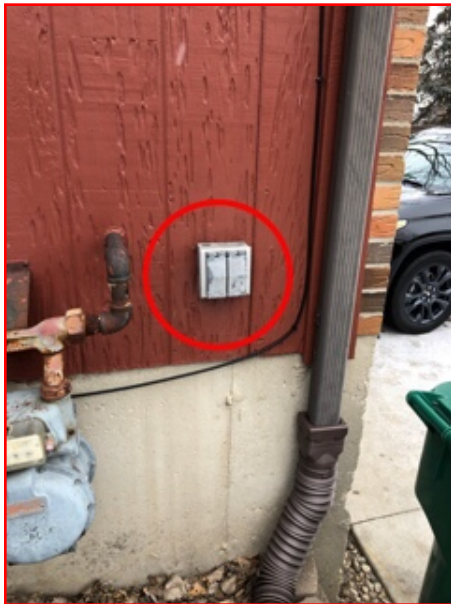
Figure 2-1

2) Exterior electrical receptacles are non-GFCI receptacles. It is recommended to have GFCI receptacles installed within six feet of any source of water. Affected receptacles are recommended to be replaced with GFCI receptacles or GFCI breakers.

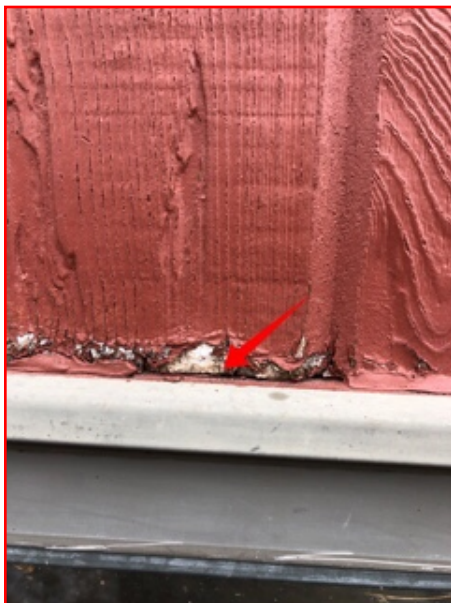
Figure 3-1

3) Paint peeling on sections of the siding. Recommend re-painting the affected areas to prevent possible rot of the siding.

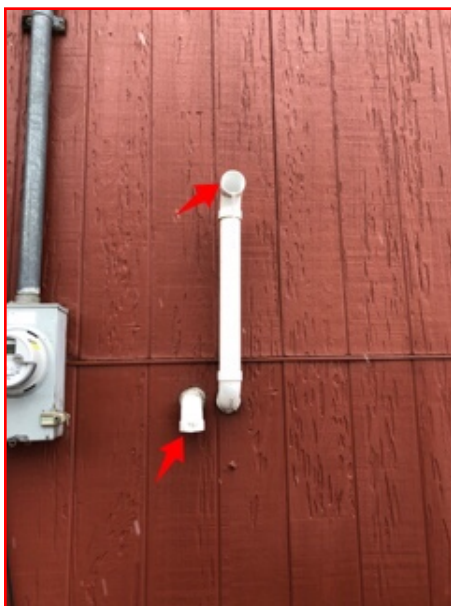
Figure 4-1

4) Exterior PVC exhaust and intake vents are recommended to be covered with screens to reduce the opportunity of possible insect and bird infiltration.

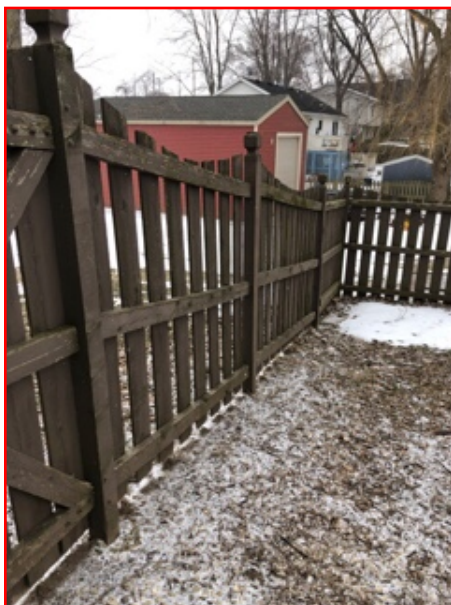
Figure 5-1

5) Fence is recommended to be power washed and re-sealed.

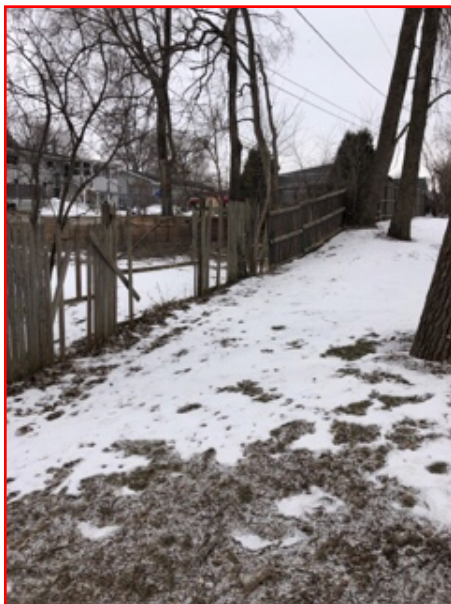
Figure 6-1

6) Sections of the fence are loose damaged and missing. Recommend replacing the affected sections of fence.

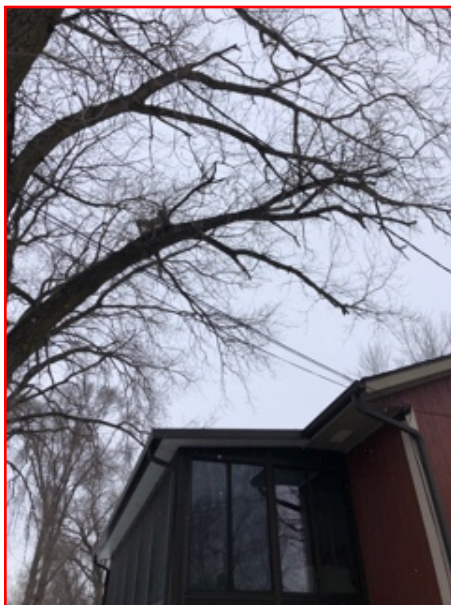
Figure 7-1

7) Recommend removing all tree branches overhanging the roof of the home.

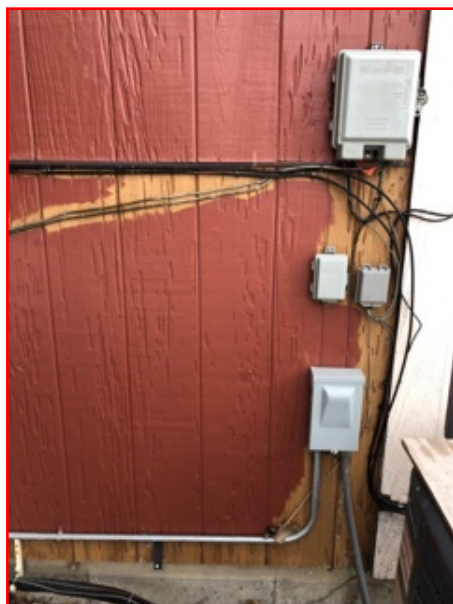
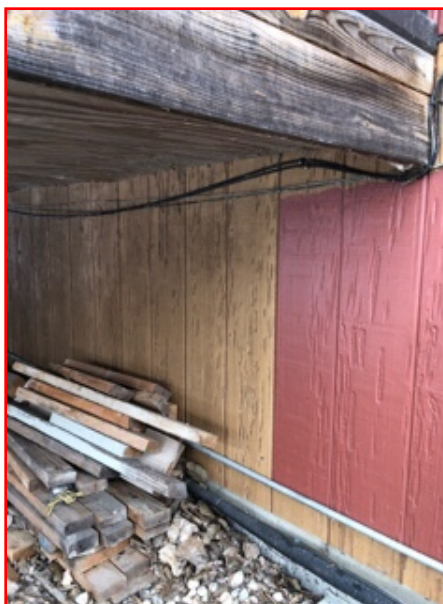
8) Recommend painting all unpainted sections of the siding to prevent possible rot.

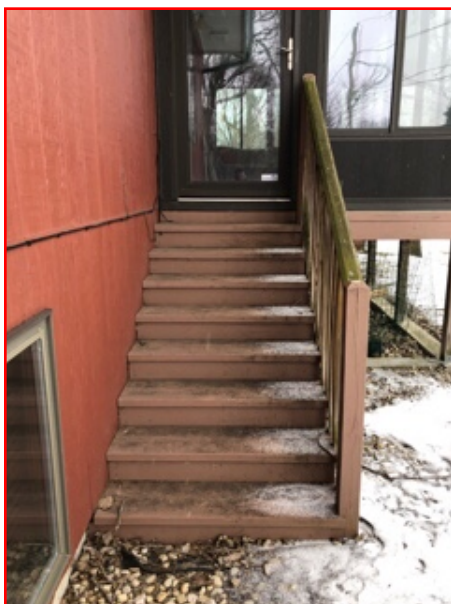
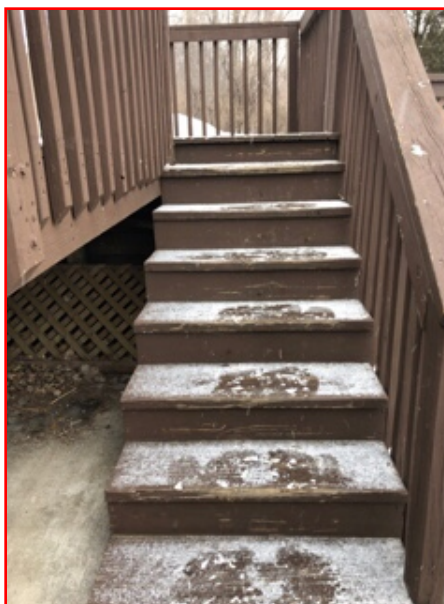
10) Front and rear step structures are missing handrails. Recommend installing graspable handrails to prevent possible trip hazards.

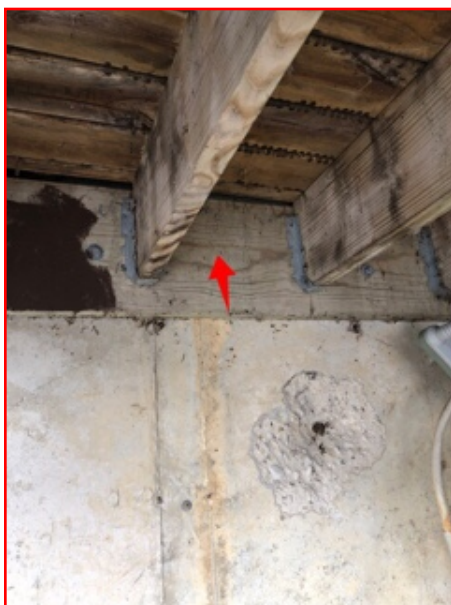
Figure 11-1

11) The front porch ledger board is not bolted properly and is missing flashing. It is recommended to have the ledger bolts installed in a staggered pattern. It is recommended to have flashing installed on the ledger board to prevent rot and possible ledger board failure. Recommend having a qualified deck contractor properly bolt and flash the ledger board.

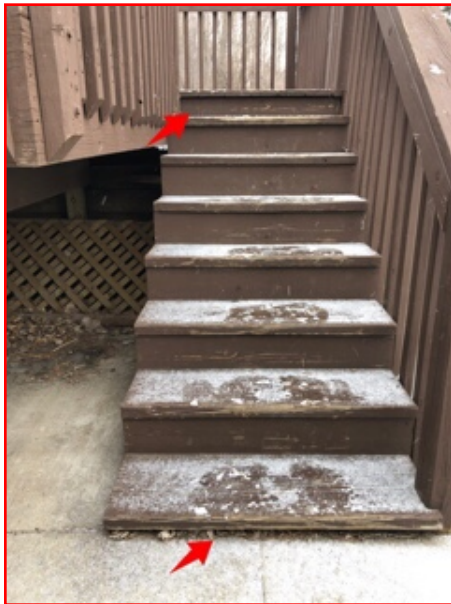
Figure 12-1

12) Front stoop step shows an irregular step riser heights. Irregular step risers are considered trip hazards. Recommend having a qualified carpenter correct the step structure.

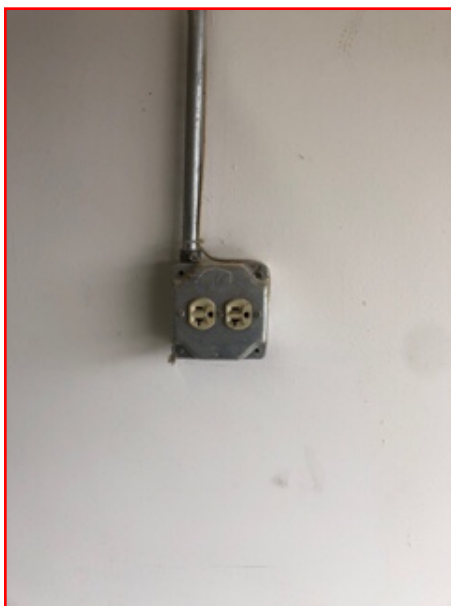
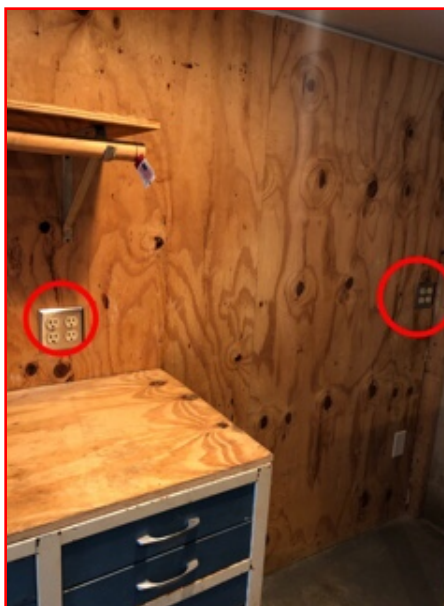
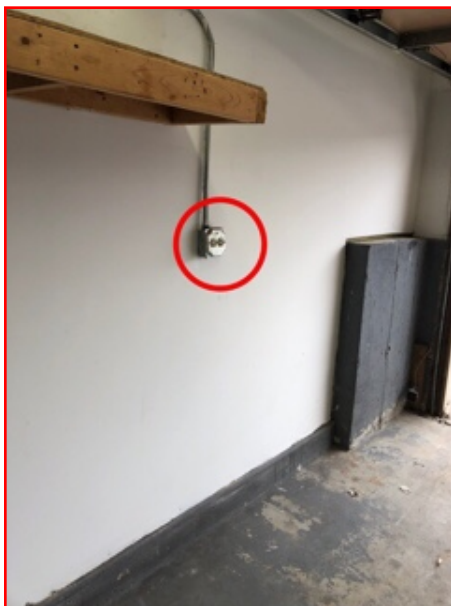
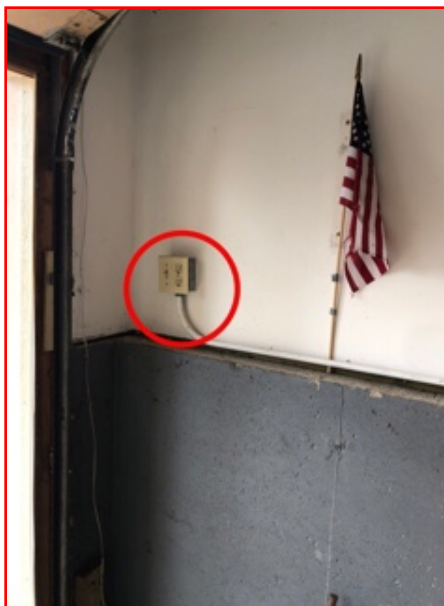
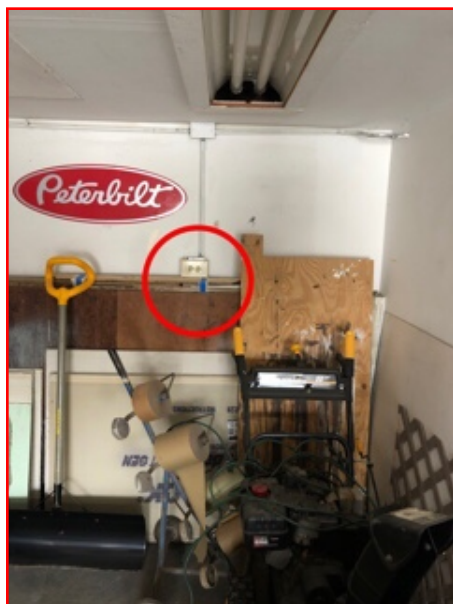
13) All garage outlets are recommended to be converted to GFCI outlets.

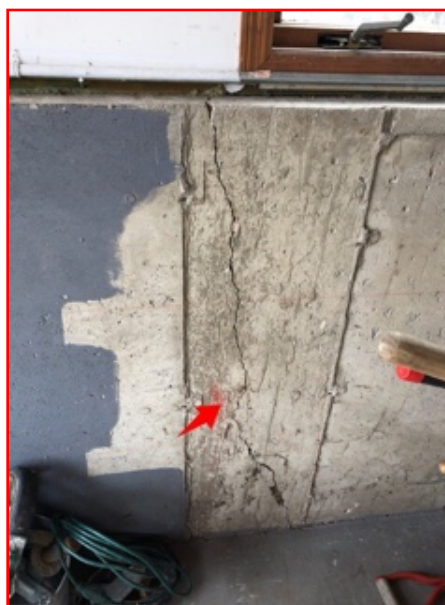
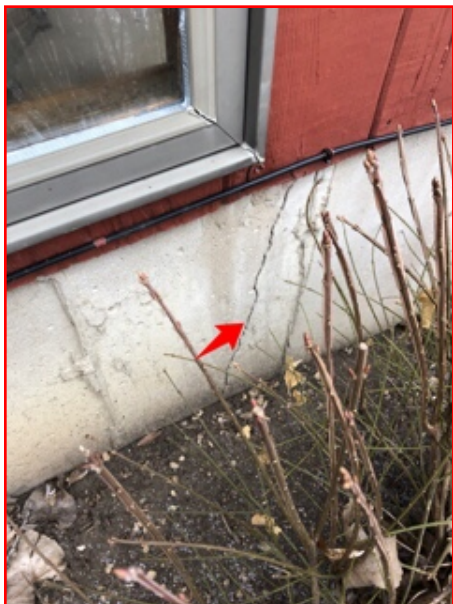
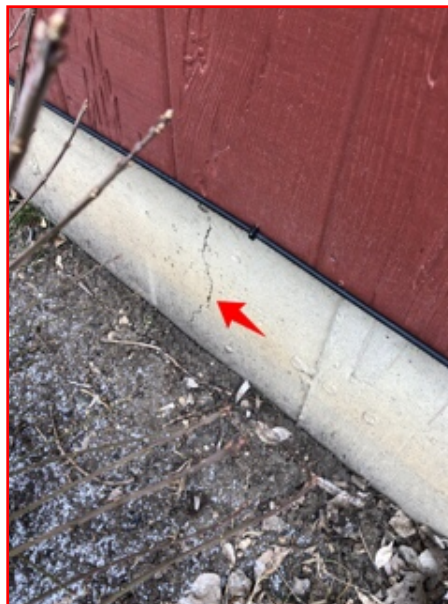
14) Vertical cracks were observed on the garage foundation walls. Some foundation cracking is typical of settlement and or shrinkage and does not usually indicate structural deficiencies. Every crack or opening in the foundation wall or floor is a potential source for moisture entry. We strongly recommend that our client makes an inquiry with the current owner as to whether there has been any moisture, seepage or flooding into the garage. Recommend monitoring the cracks for movement or leaks. If movement or leaks occurs the cracks will be recommended to be repaired.

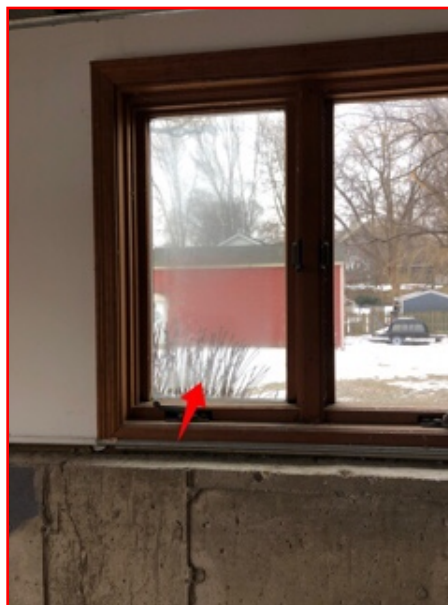
Figure 16-2

15) Garage left side window frame is rotted and has a failed seal. Recommend having a qualified window contractor correct the window.

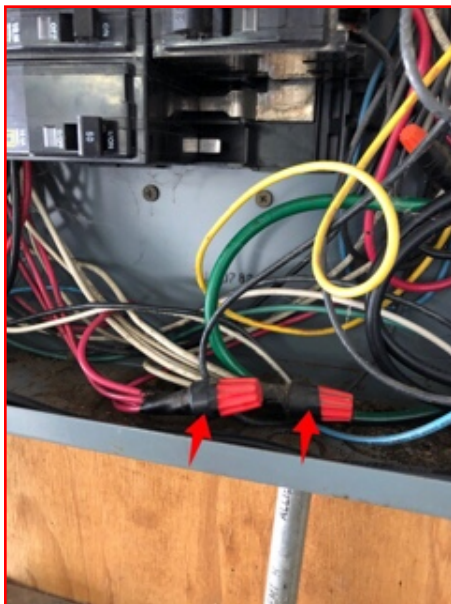
Figure 22-1

19) The electrical service panel showed several branch circuits wired together with a wire nut connecting to a breaker. It is recommended having branch circuit wires wired to individual breakers to reduce the opportunity of overloading breakers due to multiple loads from addition branch circuits. Recommend having a qualified electrician correct the wiring in the panel.

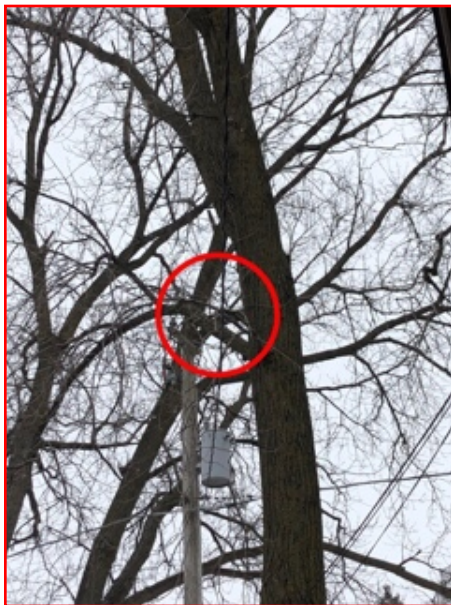
Figure 23-1

20) Main service wires are rubbing on a tree branch. Recommend trimming the tree branch to prevent the wires from rubbing.

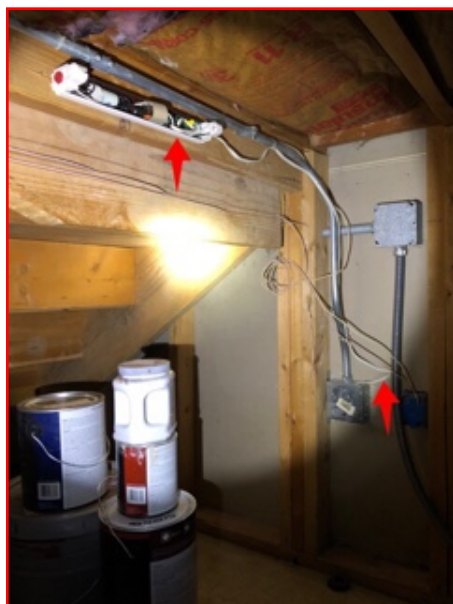
Figure 24-1

21) The under stairs light is not wired properly (illegal wiring). Recommend removing the light and wiring. Recommend having a qualified electrician wire and install a light fixture properly.

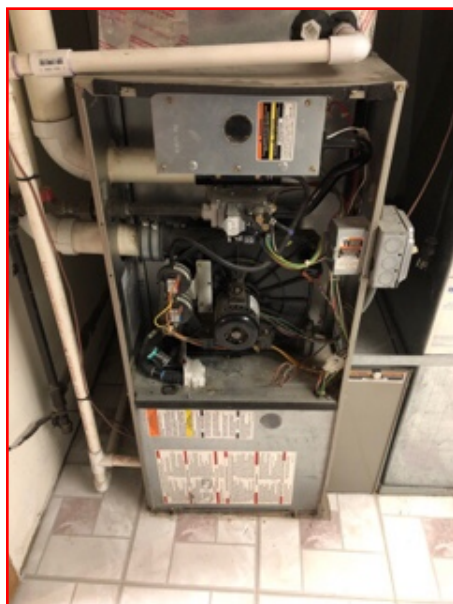
Figure 26-1

22) HVAC unit appears to have been Mfg. in 2008 and there are no signs of recent service to the HVAC unit. HVAC systems due require routine maintenance as proper operation of all units should be verified prior to closing. Heat exchangers should be inspected and certified by a heating contractor as evaluation of a furnace heat exchanger or a boiler combustion chamber requires dismantling of the unit, including burner removal, and is, therefore, beyond the scope of this inspection. Although the HVAC units were operational at the time of the inspection, further evaluation from a professional HVAC individual is recommended to further evaluate the overall condition of the HVAC units due to no signs of recent service.

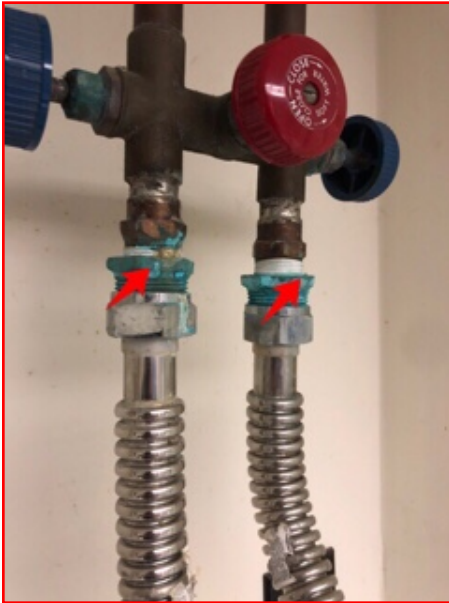
Figure 30-1

24) Dissimilar metals were observed throughout the home without appropriate fittings. Corrosion is occurring due to dissimilar metals being in contact with each other and not having appropriate fittings installed. Recommend having a qualified plumber correct all affected connections to prevent possible leaks.

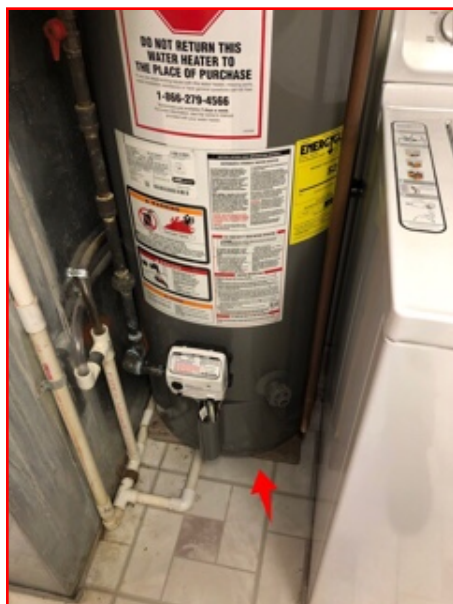
Figure 32-1

25) The water heater was missing an overflow pan. Although it is not uncommon to see this item not installed, an overflow pan is recommended to be installed under the water heater and if possible connected to a floor drain to reduce the opportunity of water seepage to adjacent floor if the water heater leaks. If no drain is present then an electrical sensor/alarm can be installed to shut down the water heater if it leaks.

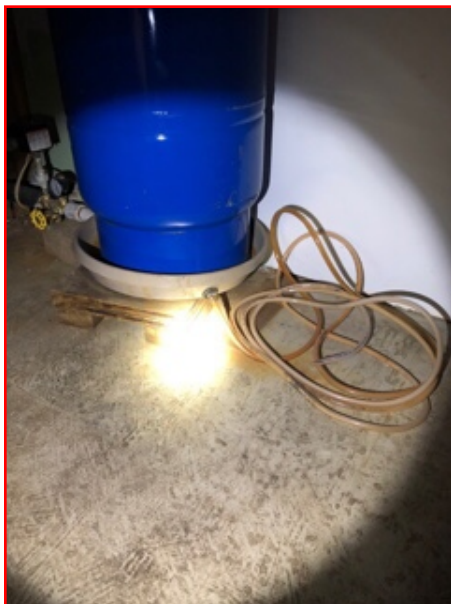
Figure 34-1

27) The water bladder overflow pan is damaged and is not connected to a floor drain. Recommend replacing the overflow pan and connecting the overflow pan to a floor drain or install a water sensor in the pan.

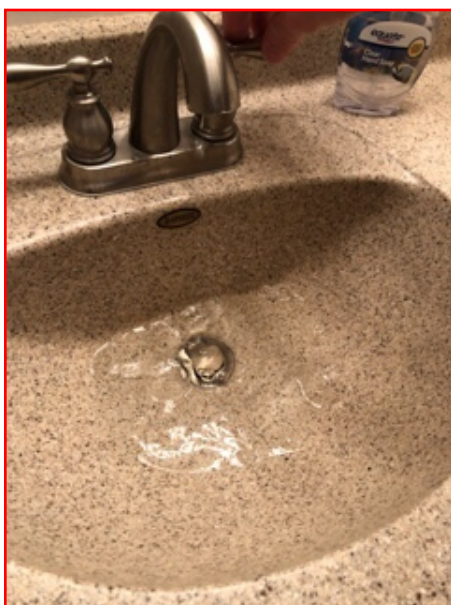
Figure 35-1

28) Hall bathroom sink has a slow drain as water drains very slowly when water is activated from the faucet. Recommend unclogging the drain connection to allow water to drain as it should.

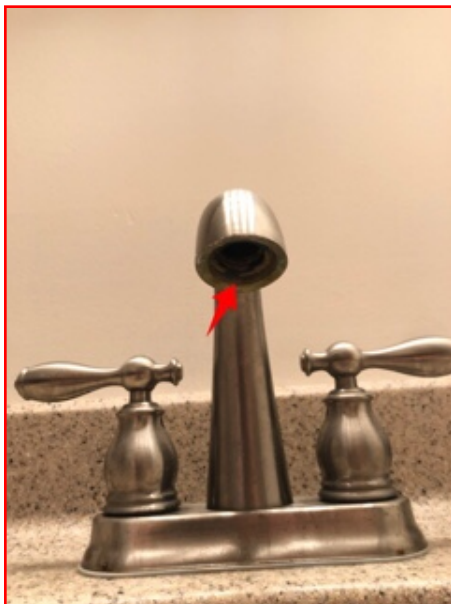
Figure 36-1

29) Hall bathroom sink faucet is missing the screen hardware. Recommend installing the sink faucet screen hardware to allow for adequate water flow.

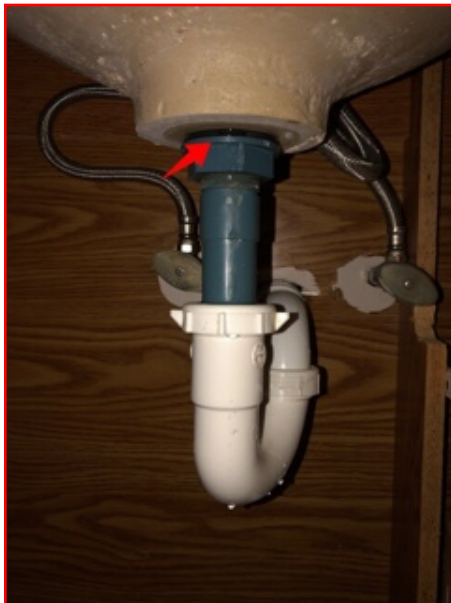
Figure 37-1

30) Hall bathroom sink drain connection leaks. Repairs are recommended to the sink drain connection to eliminate the water leak.

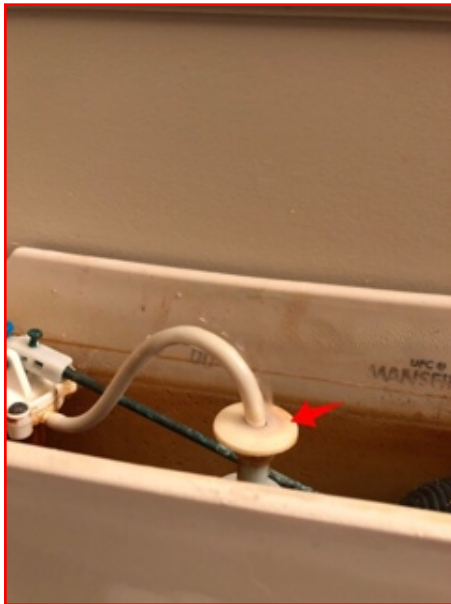
Figure 38-1

31) Toilet is not filling properly. Water is spraying from the fill tube. Recommend replacing the toilet tank components.

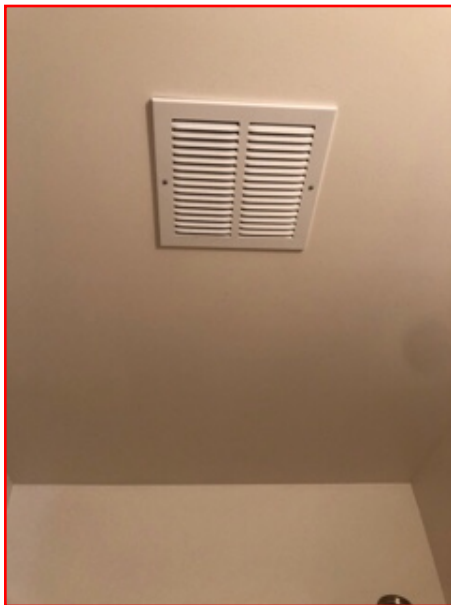
Figure 39-1

32) Hall bathroom ventilation fan is noisy when in use. Fan is at or nearing the end of its serviceable life. Replacement is recommended.

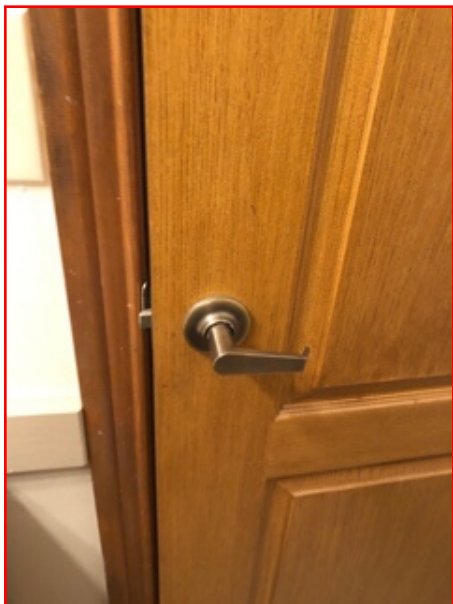
Figure 40-1

33) Hall bathroom door will not latch when closed, door hardware is recommended to be adjusted to allow the door to close, latch and lock when necessary.

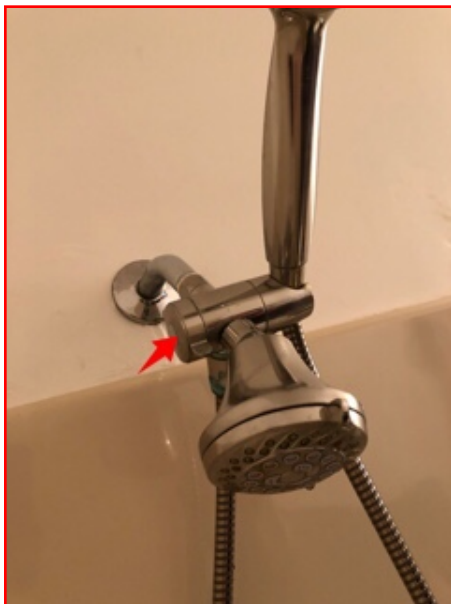
Figure 42-1

35) The shower head diverter is inoperable as both shower heads run at the same time. Shower head pressure is extremely low due to the faucet diverter not diverting completely. Recommend having a qualified plumber correct the diverter and replace the shower head.

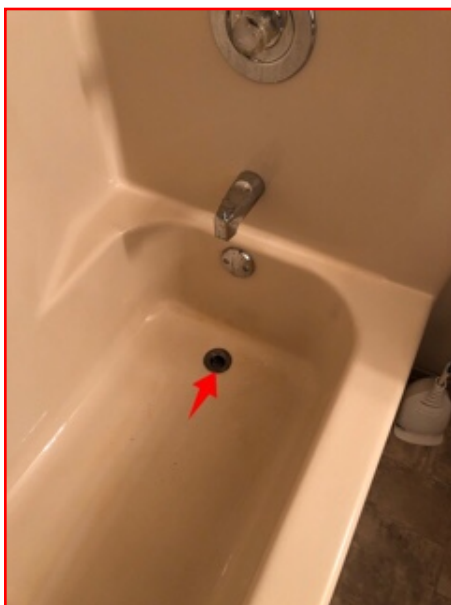
Figure 43-1

36) Tub stopper is missing. Recommend installing a tub stopper to allow the tub to hold water when necessary.

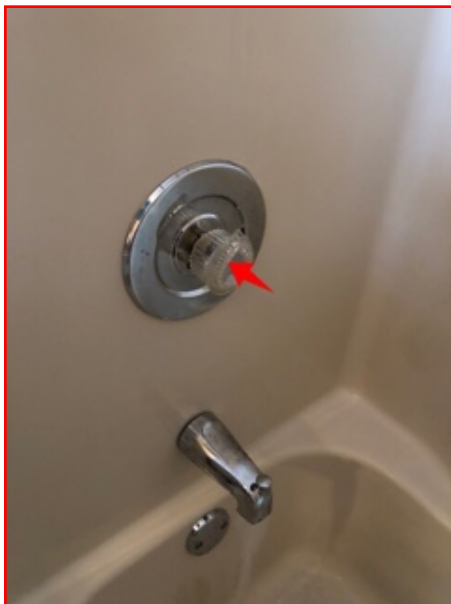
Figure 50-1

43) Tub faucet handle is hard to turn on and off. The faucet handle does not stop at max hot or cold. Replacement of the faucet hardware is recommended.

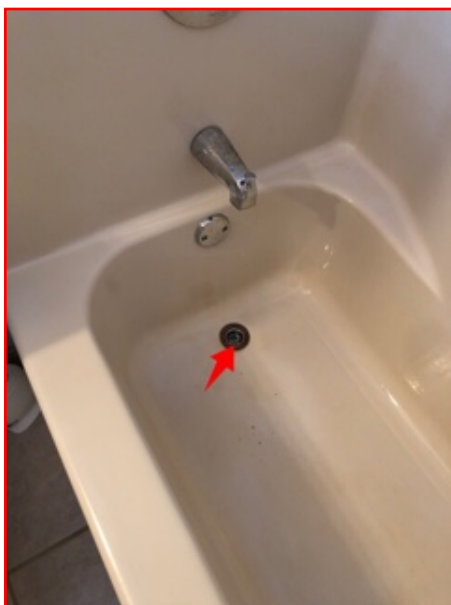
Figure 51-1

44) Tub stopper is missing. Recommend installing a tub stopper to allow the tub to hold water when necessary.

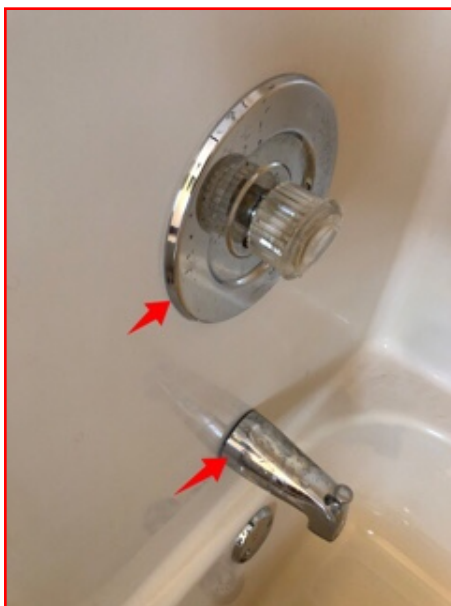
Figure 52-1

45) Recommend caulking tub faucet fixtures to the wall to prevent possible seepage behind the tile wall when the shower is in use.
