Home Inspection Report

123 Sample St.

Chicago, IL

Inspected on Fri, Mar 8 2019 at 10:00 AM

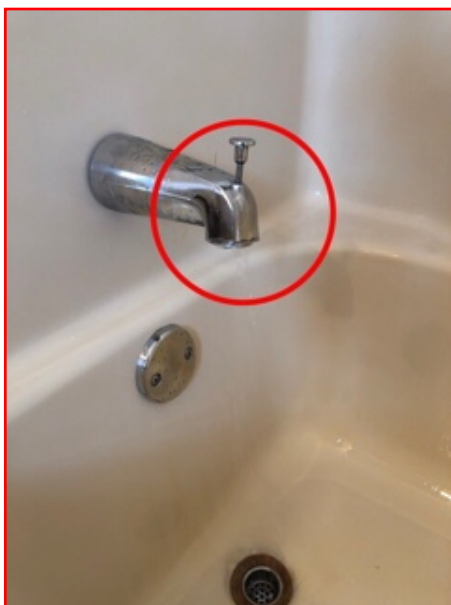
Figure 53-1

46) Bathroom tub shower diverter is not diverting water completely. Replacement and/or repairs for shower diverter are recommended to allow for proper water pressure from showerhead along with reducing water waste when the shower is activated.

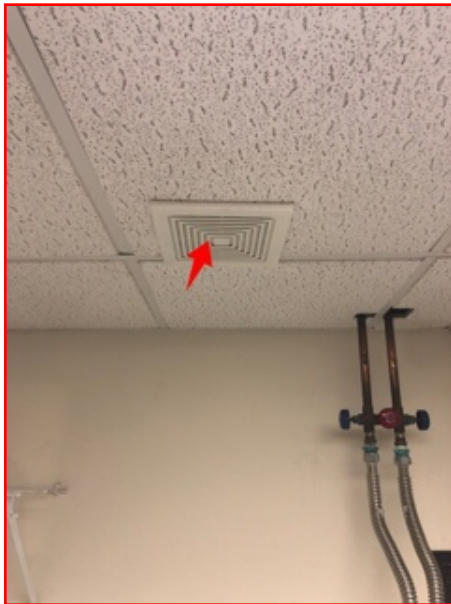
Figure 56-1

49) Basement bathroom ventilation fan is noisy when in use. Fan is at or nearing the end of its serviceable life. Replacement is recommended.

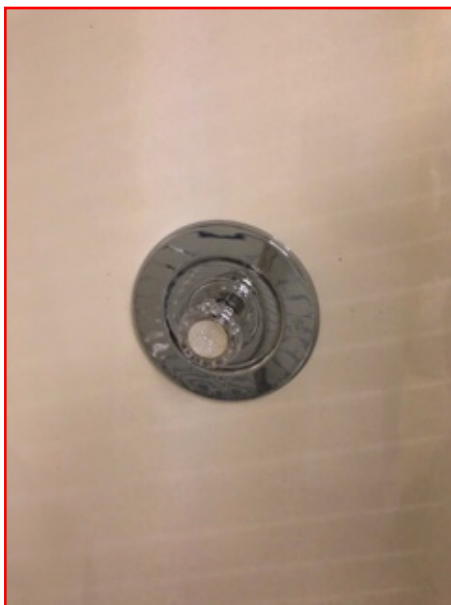
Figure 57-1

50) Bathroom shower faucet hot and cold are reversed. Recommend reversing the hot and cold distribution lines and/or faucet mechanism to allow for correct sides of water temperature for the showerhead.

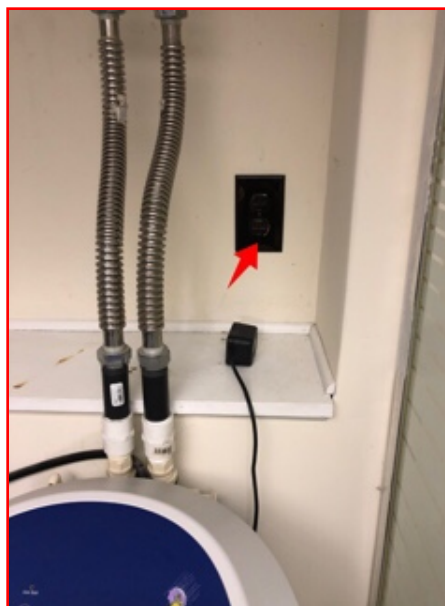
Figure 58-2

51) Laundry room electrical receptacles are non-GFCI receptacles. It is recommended to have GFCI receptacles installed within six feet of any source of water. Affected electrical receptacles are recommended to be replaced with a GFCI receptacles.

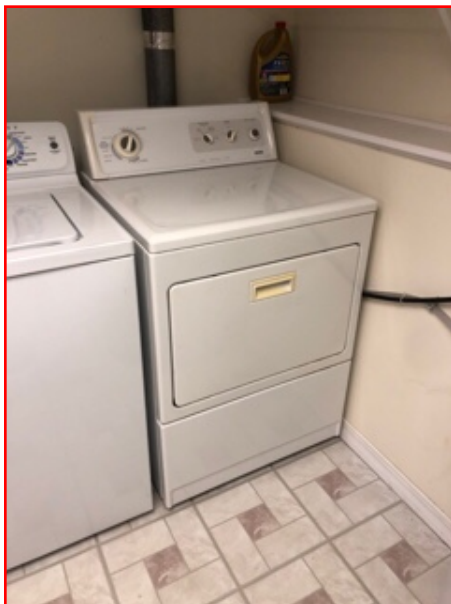
Figure 61-1

54) Dryer is vibrating when in use(out of balance). Recommend having a qualified appliance contractor evaluate and determine repairs necessary. Replacement of the dryer may be necessary.

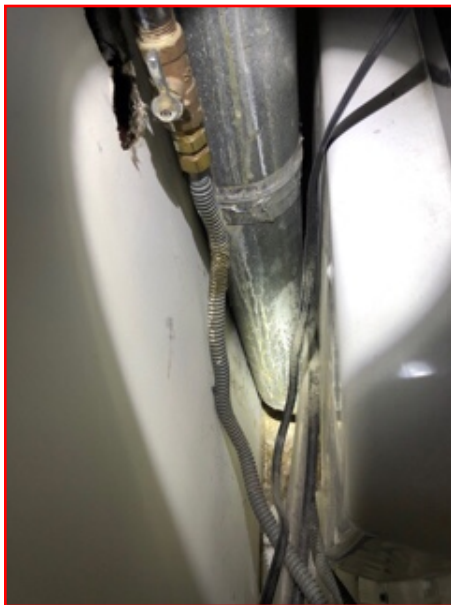
Figure 62-1

55) The dryer vent is slightly detached at the back of the dryer. Recommend securing the dryer vent to the dryer.

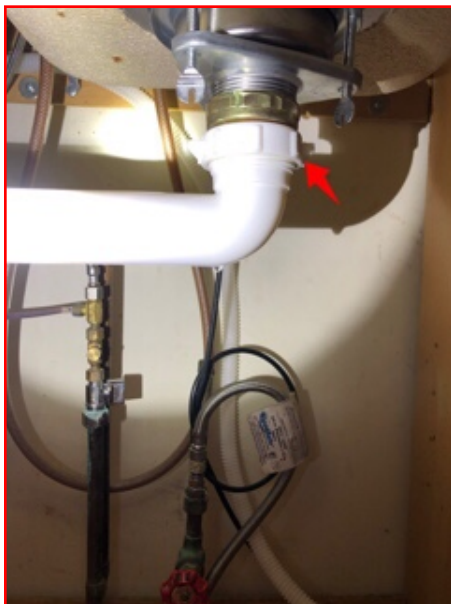
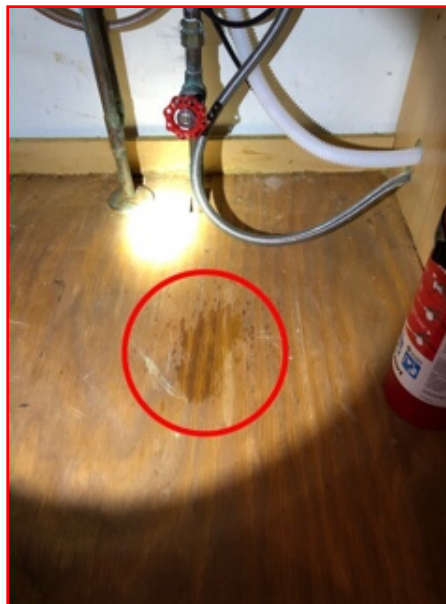
56) Right side sink drain connection leaks as water was observed dripping along with water observed on the floor of the cabinet. Repairs are recommended to eliminate the water leak and possible water damage to base cabinet unit.

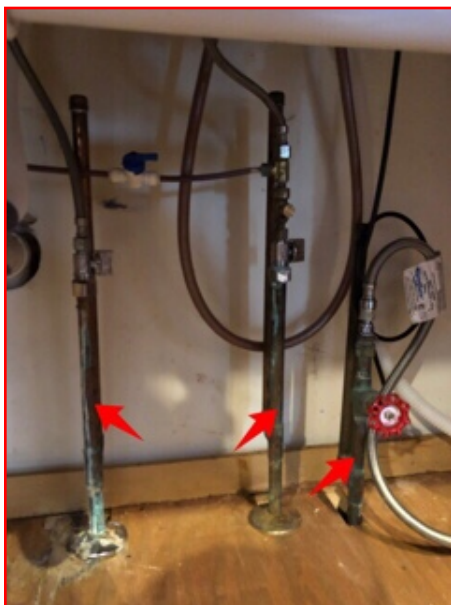
Figure 64-1

57) Water pipes are loose under the sink. Recommend securing the pipes to the wall to prevent excessive movement when in use.

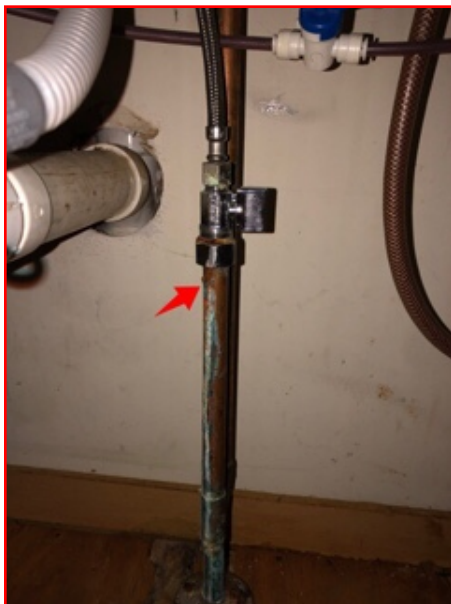
Figure 65-1

58) Hot water supply valve connection leaks. Recommend having a qualified plumber correct the leak.

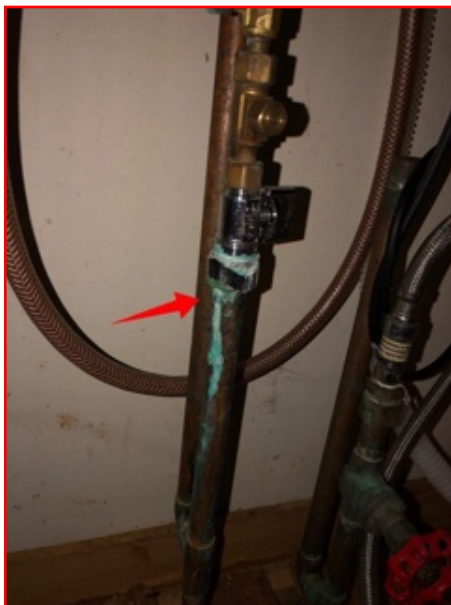
Figure 66-1

59) The kitchen cold water supply valve connection has a pine hole leak. Recommend having a qualified plumber correct the leak.

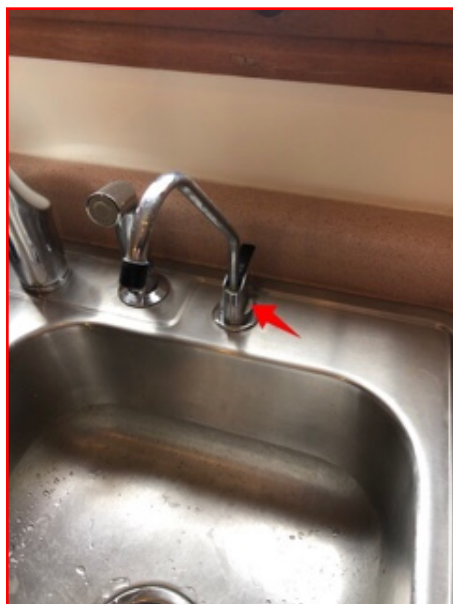
Figure 67-1

60) The small faucet is not connected to a water source and is inoperable.

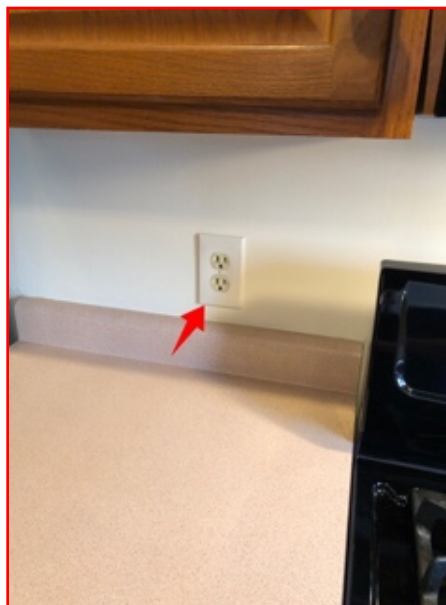
Figure 68-2

61) Electrical receptacles are non-GFCI receptacles. It is recommended to have GFCI receptacles installed within six feet of any source of water. Affected electrical receptacles are recommended to be replaced with a GFCI receptacle.(all kitchen outlets)

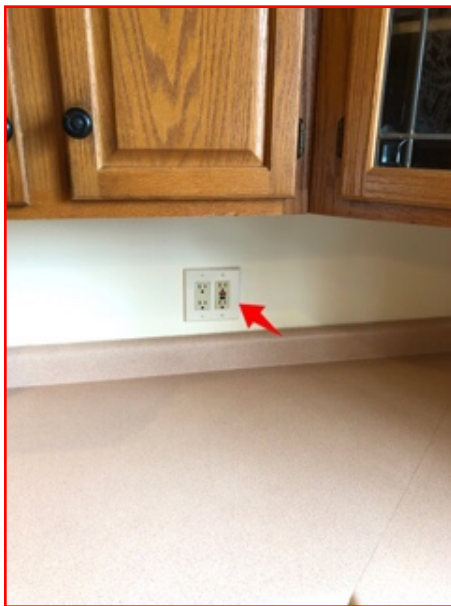
Figure 69-1

62) Kitchen GFCI receptacle was not functioning properly. When testing the GFCI receptacle at the receptacle and with a circuit tester, when attempting to trip and reset the GFCI receptacle, the GFCI receptacle would not trip. Replacement is recommended to allow the GFCI receptacle to trip when necessary to reduce the possibility of electrical shock hazards.

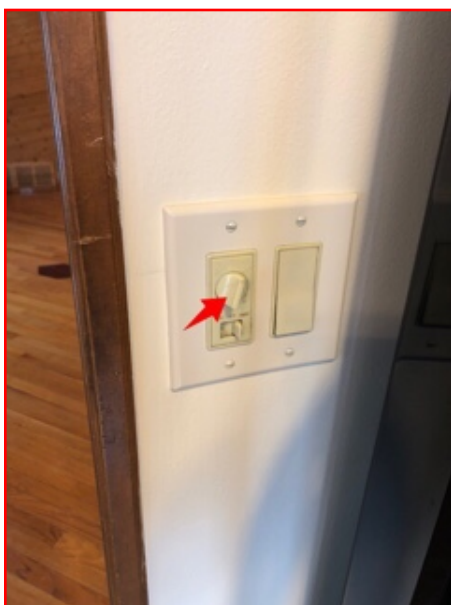
Figure 70-1

63) The fan wall switch is damaged/inoperable. Replacement of the switch is recommended.

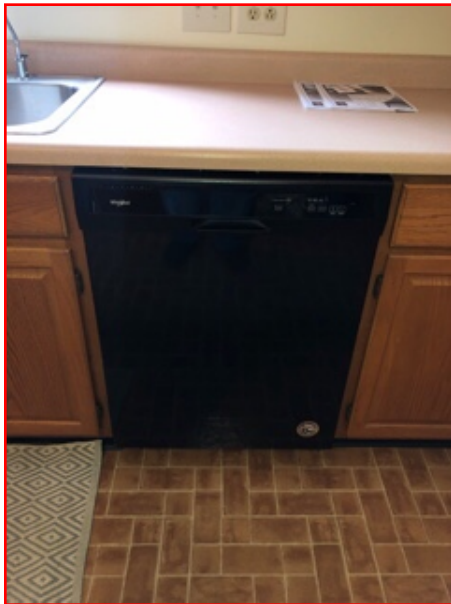
Figure 71-1

64) The seller disclosed the dishwasher (new) is not working properly and is to be repaired. Recommend verifying the dishwasher is in proper working condition.

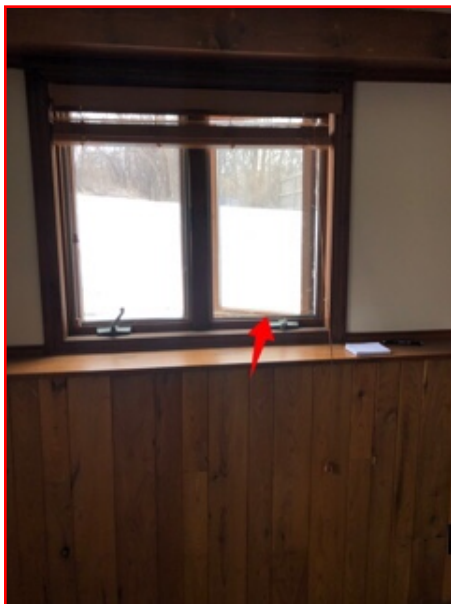
Figure 73-1

66) Basement north left hand side window crank is stripped and the window will not close on its own. Repairs are recommended to allow the window to open and close properly.

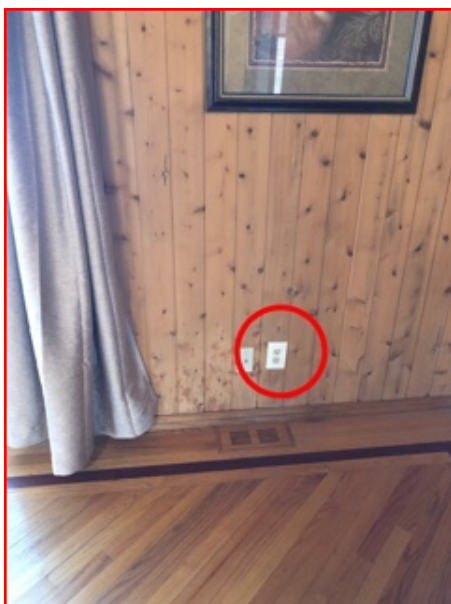
Figure 76-1

68) Family room west wall right side outlet was a loose wire connection. When testing the outlet the tester was flickering. Recommend having a qualified electrician correct the wiring to the outlet.

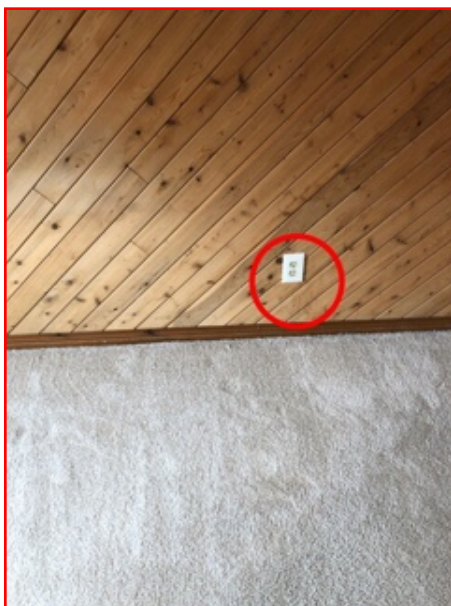
Figure 77-1

69) Master bathroom south wall right side outlet is loose. Recommend securing the outlet to prevent excessive movement when in use.

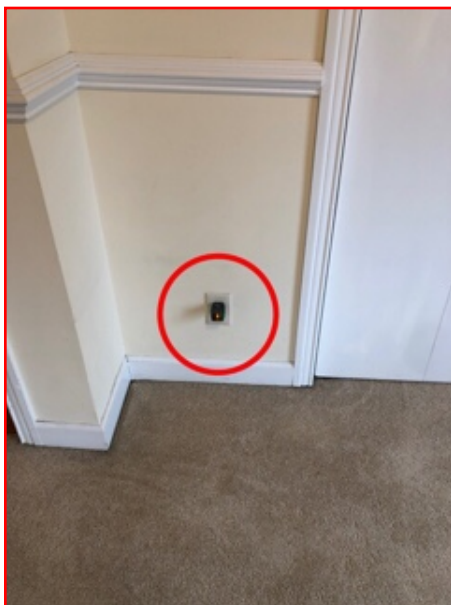
Figure 78-1

70) The northeast bedroom west wall electrical receptacle is a non-grounded outlet. A grounded outlet introduces a shock path to the ground. A non grounded receptacle does not have the shock path to ground. Affected receptacle is recommended to be grounded to reduce the opportunity of appliance failure and potential shock hazards if power surges occur. Recommend having a qualified electrician correct the affected outlet.

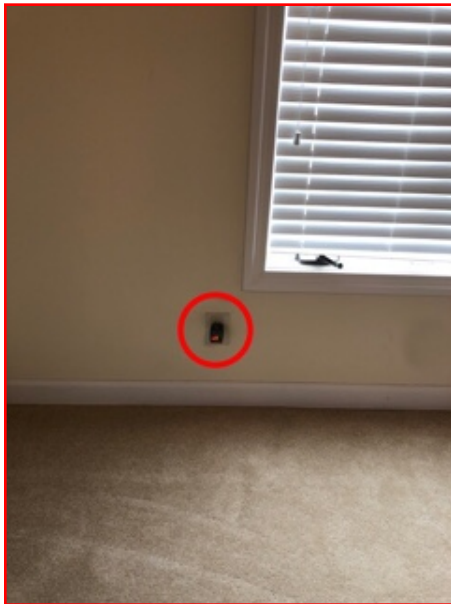
Figure 79-1

71) Northwest bedroom north wall outlet is not wired properly. When testing the outlet with a circuit tester the outlet shows to be wired reversed polarity. Recommend having a qualified electrician correct the wiring to the outlet.

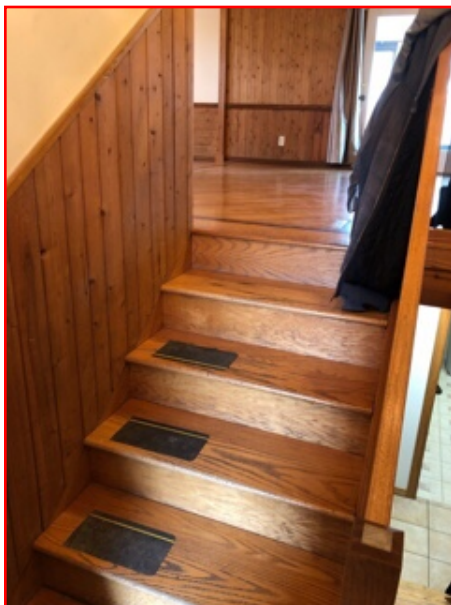
Figure 80-1

72) Front entry steps is missing a graspable handrail. Recommend installing a graspable handrail to prevent possible trip hazards.

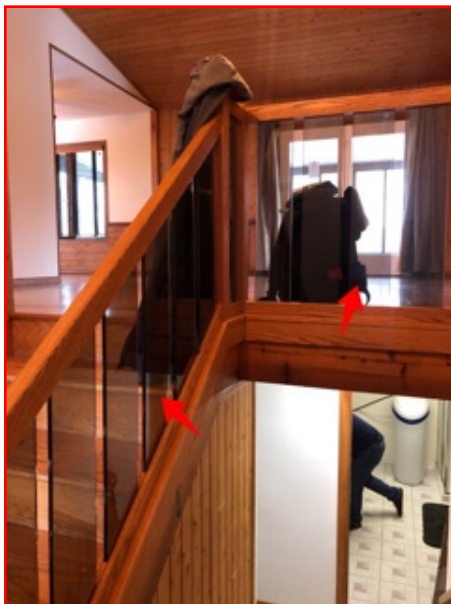
Figure 81-1

73) Railings to the second level are too low and considered hazardous. Railings are recommended to be at least 36" above the floor. Recommend having a qualified carpenter correct the railings.
